**AN INVESTIGATION INTO THE FLOOD HAZARDS FACED BY
THE COMMUNITY LIVING NEAR KALIKILIKI DAM IN
MTENDERE COMPOUND – LUSAKA**

**CHRISPIN MOYO
(COMPUTER. No. 94223670)**

A Projected submitted to the Department of Geography at the University of Zambia in partial fulfillment of the degree of Bachelor of Science, BSc.

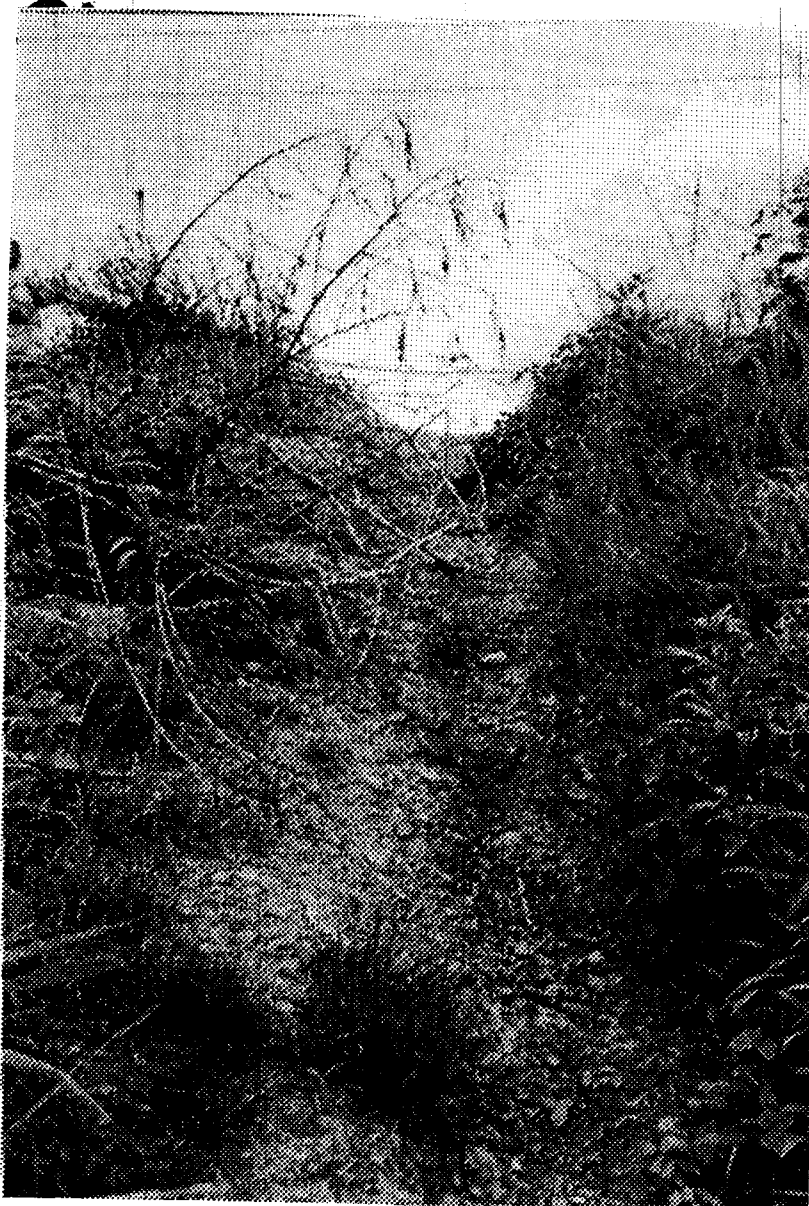
Soil erosion was taking place on the downstream face of the Kalikiliki Dam and on top of the dam which serves as a road (Plates 5.1 and 5.2).

Plate 5.1: Soil Erosion taking place along a human path on the downstream face of Kalikiliki Dam

Rain water appeared to be the main eroding agent. On some human paths on the dam, soil erosion had resulted in gullies with no visible signs of measures put in place to control the erosion. The top of the dam, was also being attacked by soil erosion.

2. There is a great need for the Lusaka City Council to maintain and protect Kalikiliki Dam in order to prevent the failure of the dam which can have some disastrous consequences on the settled area along Kalikiliki stream.
3. Local authorities or Councils in Zambia need to come up with a Policy (if there is none) that should restrict people from settling near earth dams.
4. There is a need to come up with alternative water level control facilities that can be used on Kalikiliki Dam without causing floods to occur in Mtendere compound.

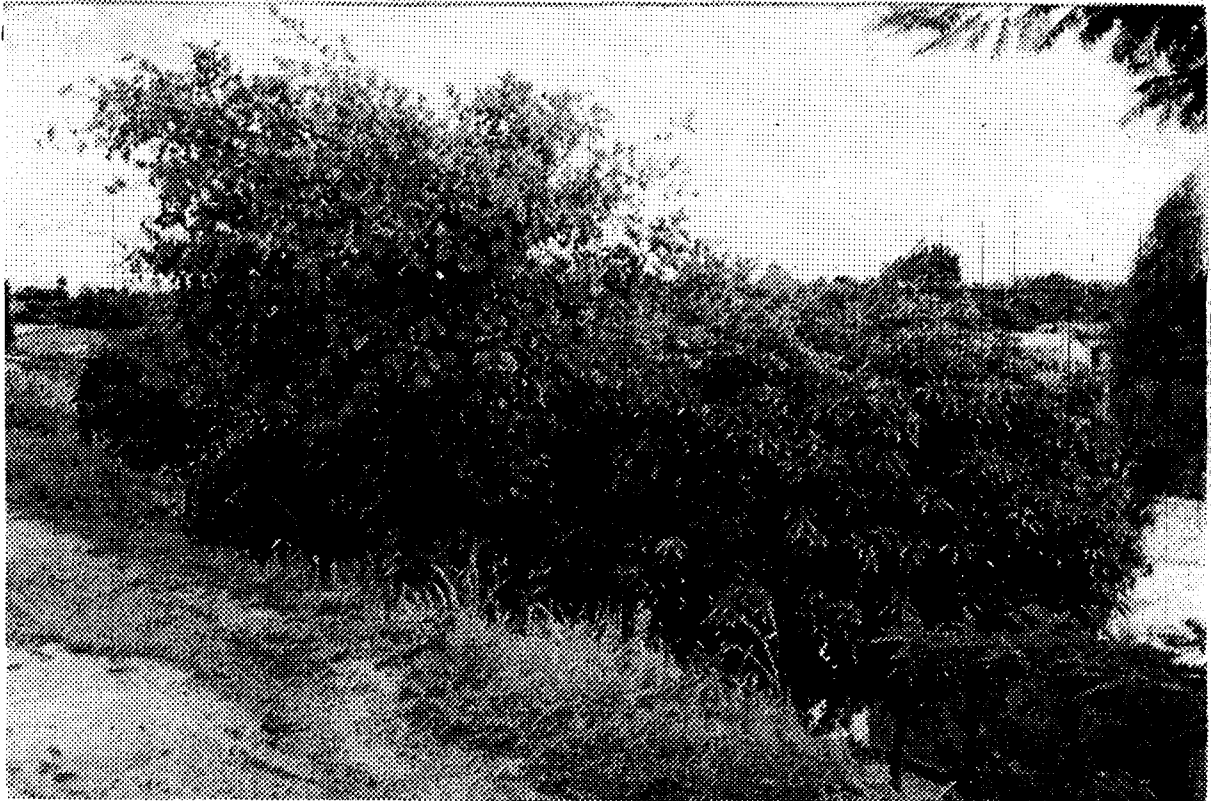
Plate 5.2: Soil Erosion on top of Kalikiliki Dam and trees growing on the Dam

Trees and shrubs were found growing on the Kalikiliki dam, on the damstream face of the dam. Plate 5.2 shows some of the trees that are growing on the dam. Mango trees, which

appeared to have been planted on the dam (in a row), were among the trees found growing on the dam (Plate 5.2).

Lack of protection of Kalikiliki dam by the Lusaka City Council was evidenced by, among other things, trees and shrubs growing on the embankment. Plate 5.2 shows some of the trees that were found growing on the embankment. Some residents have, apparently, gone to the extent of planting Mango trees on the embankment (Plate 5.2). Trees should never be allowed to grow on the embankment because when they die and get decomposed, their roots create path ways for insects, animals and water. This can lead to piping and eventually to breaching of the dam.

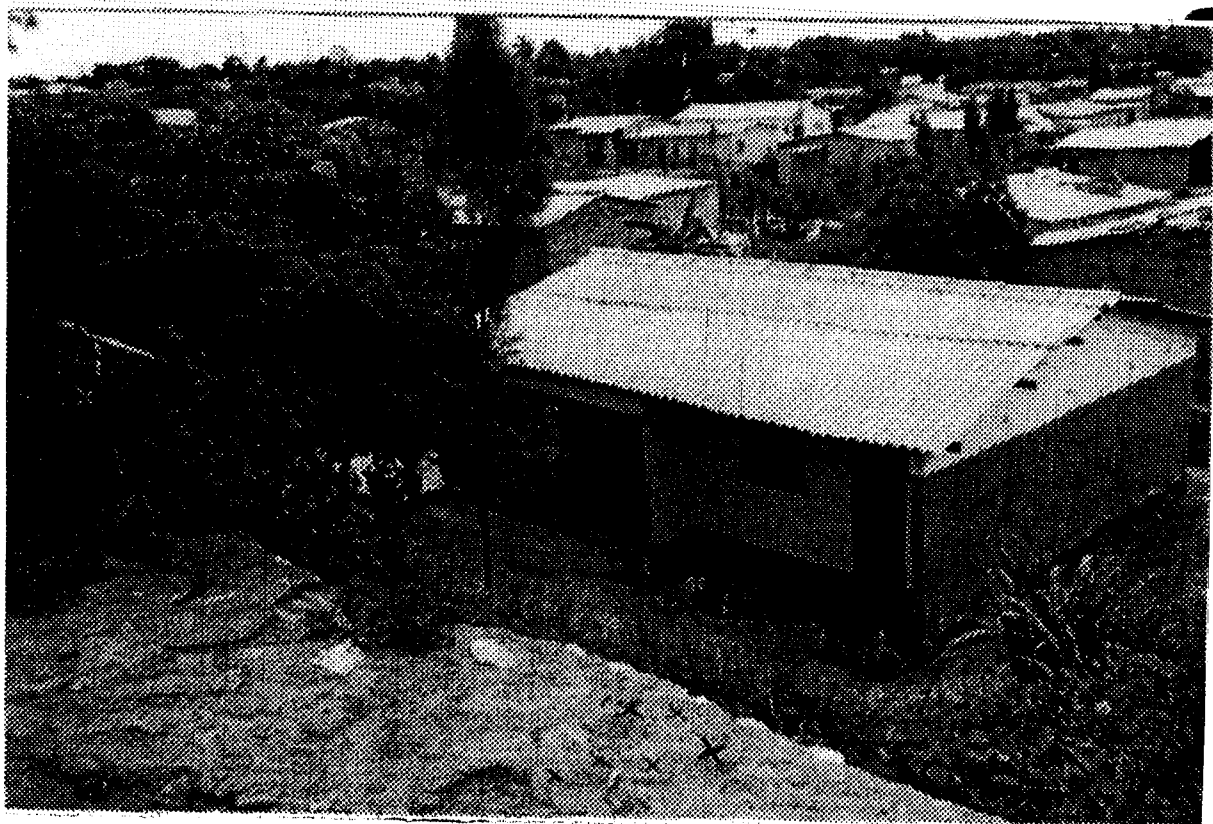
Apart from the spillway, Kalikiliki Dam has got two culverts that are located under the road on top of the dam. Plate 5.3 shows the location of one of the two culverts. The diameter of the two culverts (pipes) was found to be 0.6m each.

Part of section-D of Mtendere compound is located close to Kalikiliki Dam. Plate 5.3 shows some of the houses in this part of the compound that are located close to Kalikiliki Dam as viewed from the top of the dam.

Plate 5.3: An overview of part of Section-D of Mtendere Compound

Note: There is a culvert under the concrete work on area marked x.

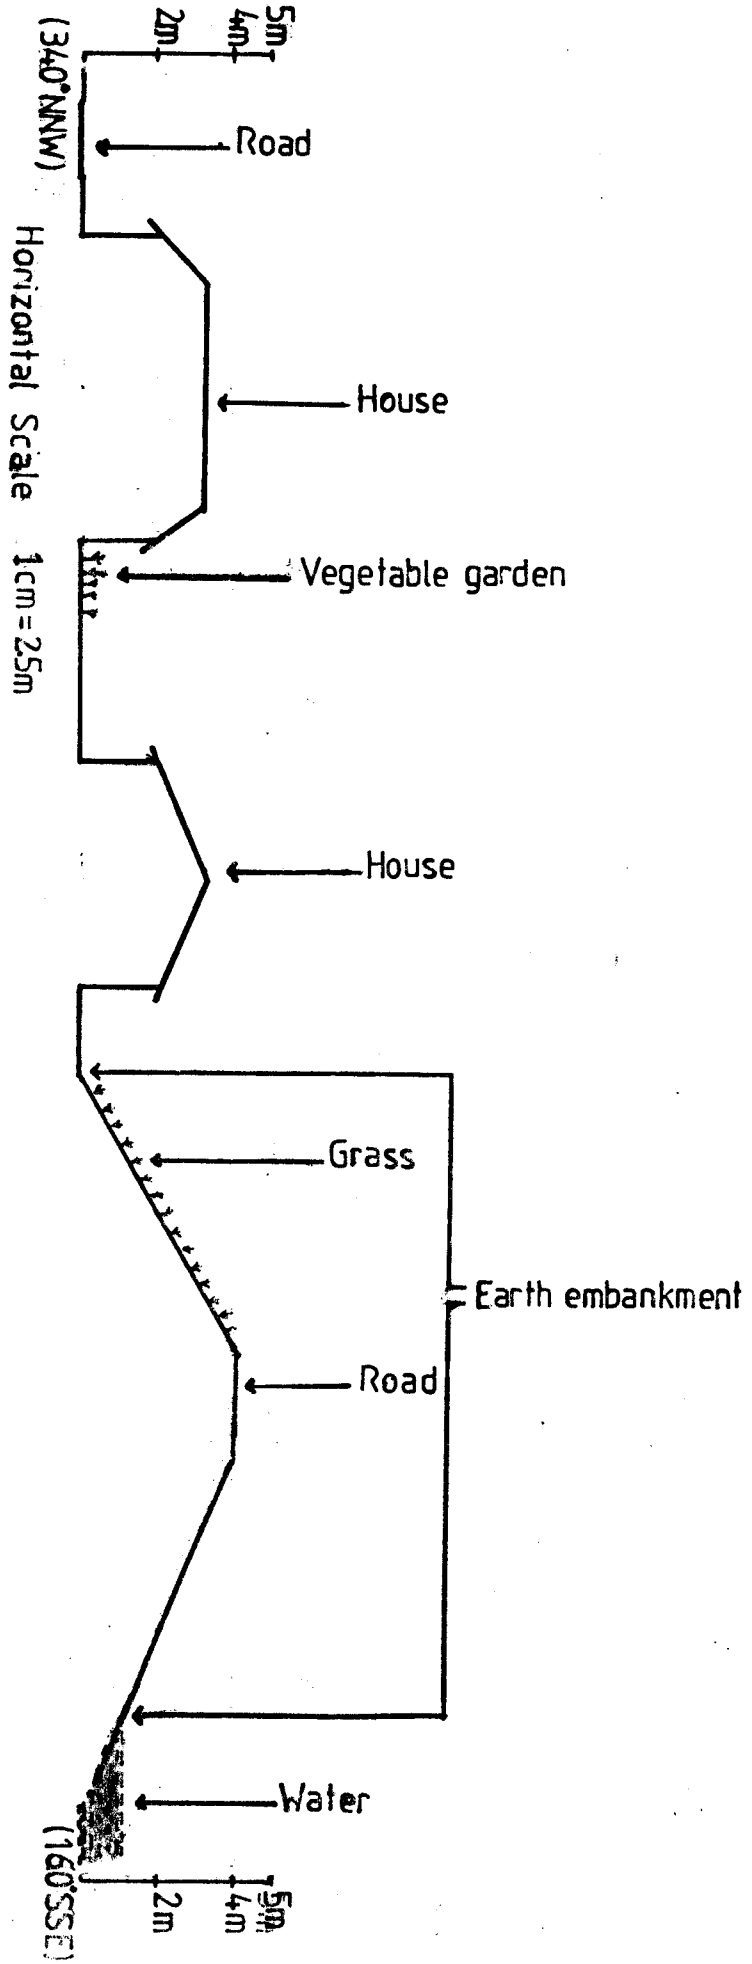
FIG. 51 A PROFILE SHOWING PART OF M TENDERE COMPOUND, KALIKILIKI DAM AND PART OF KALIKILIKI POND

Figure 5.1 shows Kalikiliki Dam and Pond and two houses (in Mtendere compound) that are among many houses in the area, located close to the dam. The water level was low in the Pond, in January, 2002, as shown in figure 5.1, following a dry spell that was experienced in the 2001 – 2002 rainy season, by January, 2002.

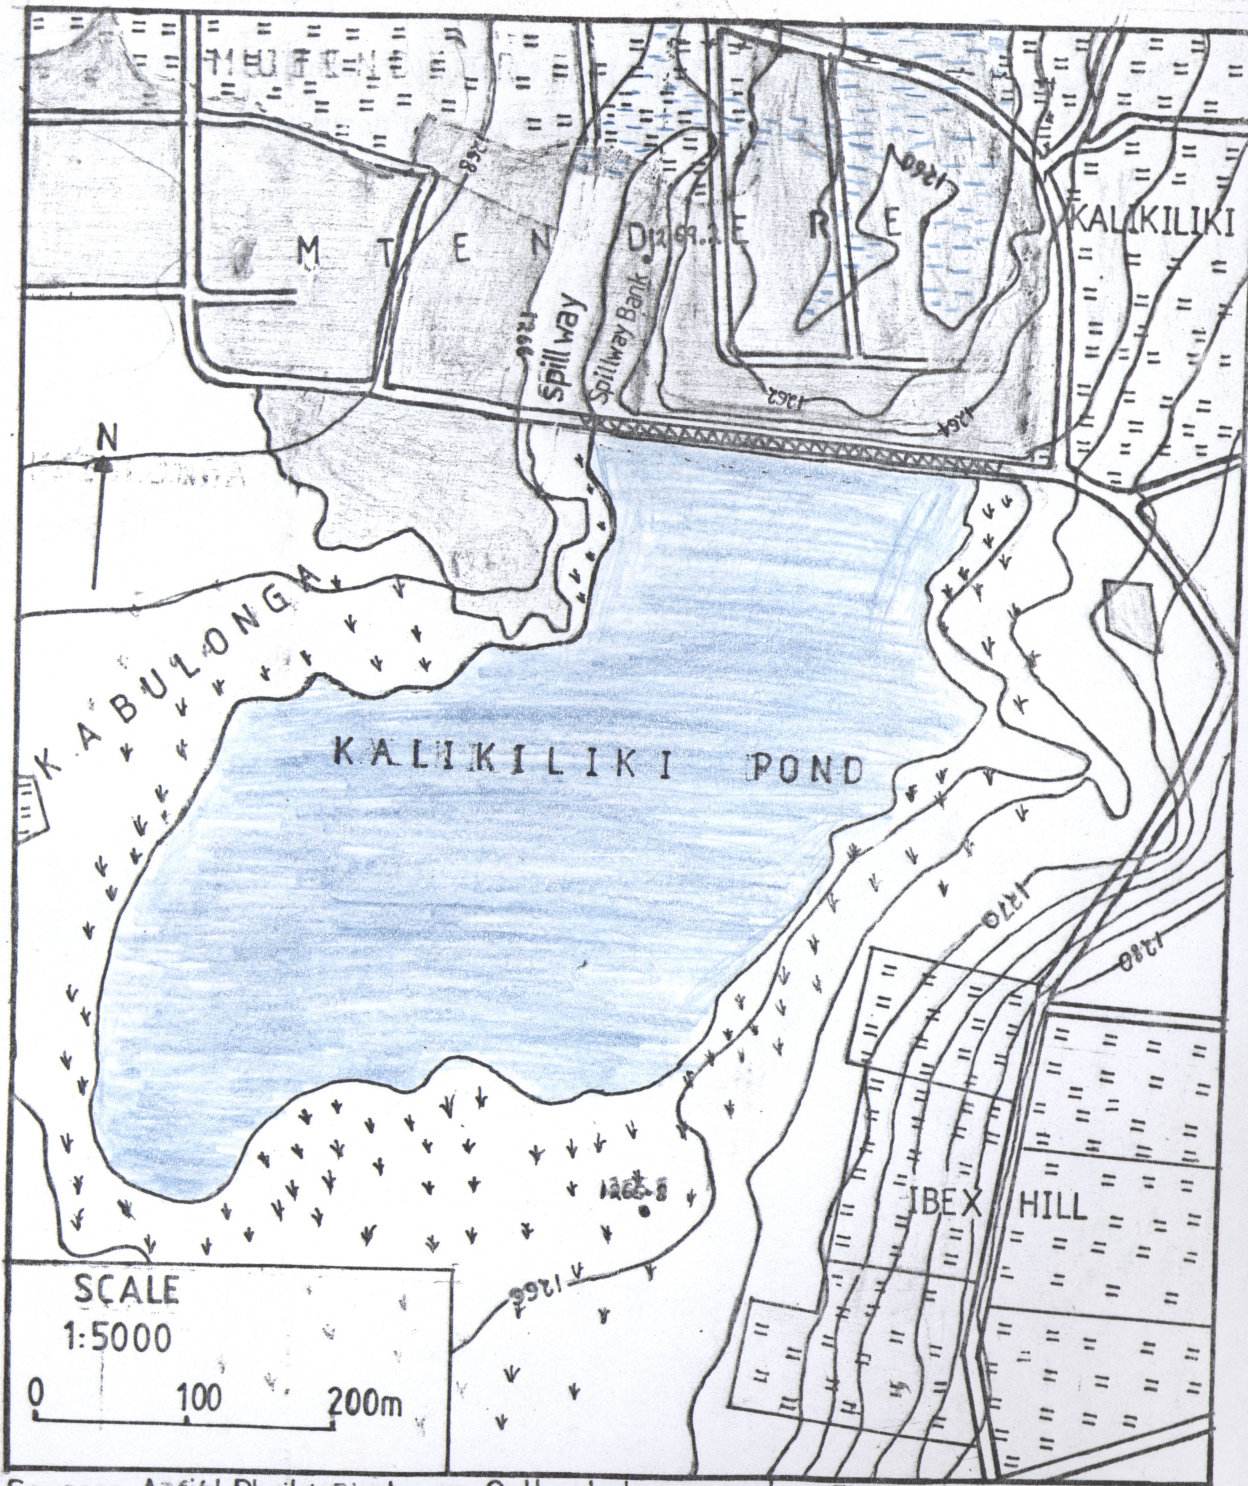
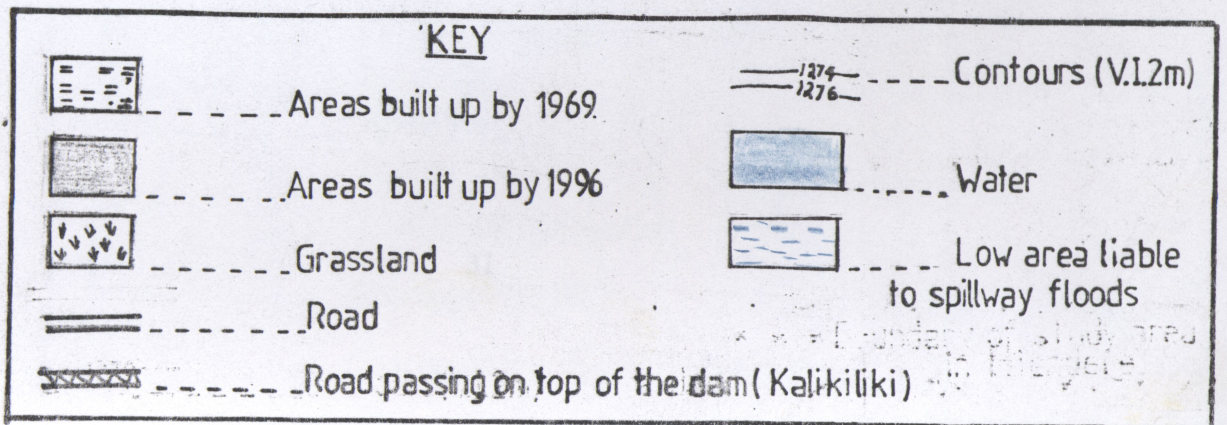
FIG52 AN OVERLAY SHOWING THE OLD AND THE NEWLY-BUILT UP PARTS OF RESIDENTIAL AREAS AROUND KALIKILIKI POND

Kalikiliki Dam has got a spillway that is located at the western end of the dam (figure 5.2). The width of the spillway was estimated at 50 metres. A completed and an uncompleted church were found to have been built in the water way of the spillway. Some houses are located at the end of the spillway (figure 5.2.).

Figure 5.2 shows the expansion of Mtendere compound towards Kalikiliki Dam. Two time periods are shown: 1969 and 1996.
