**SEDIMENTATION AND ITS EFFECTS ON SELECTED SMALL DAMS IN LUSAKA  
PROVINCE, ZAMBIA**

**A dissertation submitted to The University of Zambia in Partial fulfilment of a Master of  
Science in Environmental and Natural Resources Management.**

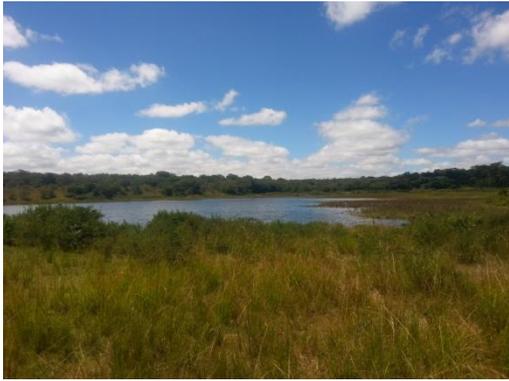
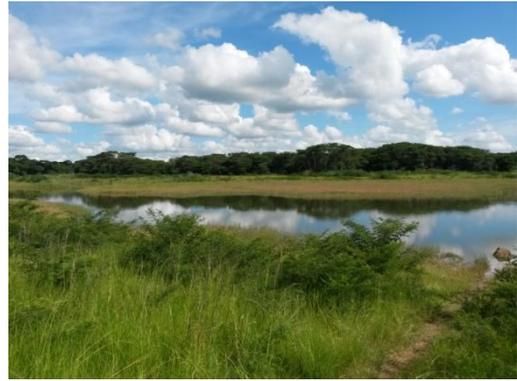
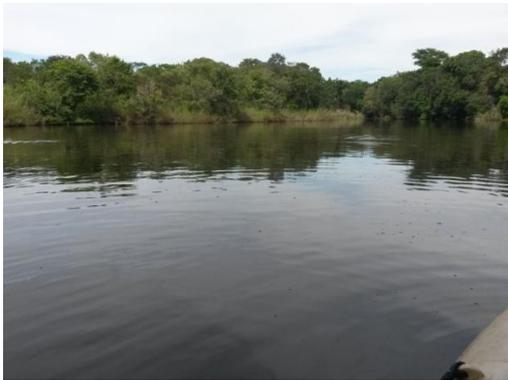
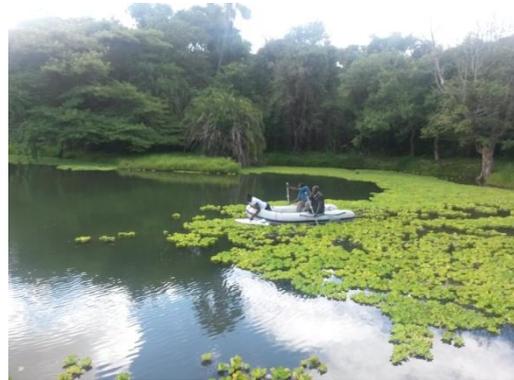
Figure 3.2: (a) Lwiimba dam (b) Silverest dam (c) Morester dam (d) Katondwe dam.(Source: Field data,2015).

Lwiimba dam (Figure 3.2a) is located at latitude 15°46' 14.68'' and longitude 28°68' 54.53'' at an elevation of 1108.25 masl. The main source of water that feeds the dam is kalanga stream. Lwiimba dam is mainly used for livestock. Within 50 meters of the dam, Lwiimba had about 45 percent of vegetation cover. Silverest dam (Figure 3.2a) is located at latitude 15°25' 37.27'' and Longitude 28°27' 50.23'' at an elevation of 1191.07 masl. The surface runoff is the main source of water that feed the dam. Silverest dam is mainly used for irrigation and livestock. Within 50 meters of the dam, Silverest had about 60 percent of vegetation cover. Morester dam (Figure 3.2c) is located at latitude 15°27' 40.35'' and longitude 28°40' 20.57'' at an elevation of 1118.06 masl. The main source of water that feeds the dam is a stream called kalanga. Morester dam is mainly used for water livestock. Within 50 meters of the dam, Morester had about 55 percent of vegetation cover. Katondwe dam (Figure 3.2d) is located at latitude 15°24' 36.12'' and longitude 30°25' 27.25'' at an elevation of 357 masl. The main source of water that feeds the dam is a Katondwe stream. Katondwe dam is mainly used for water supply for Katondwe hospital and Katondwe School. Within 50 meters of the dam, Katondwe had about 90 percent of vegetation cover.

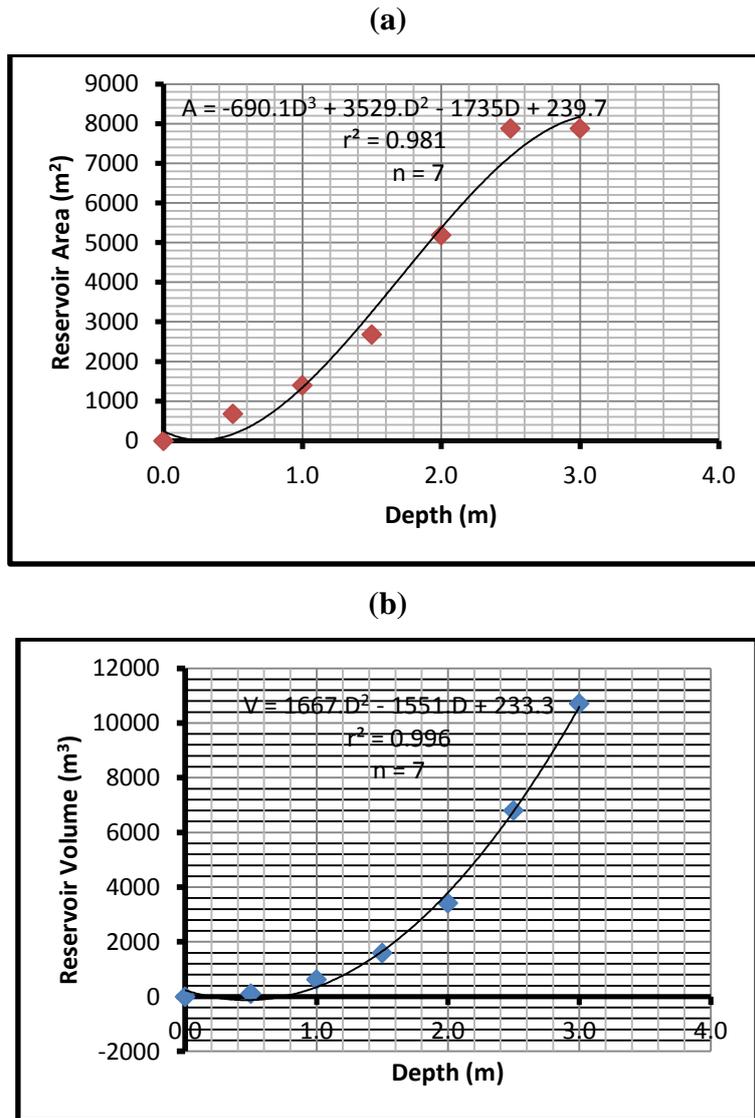
Figure 5.8: Hypsometric graphs showing (a) Depth- Area and (b) Depth-Reservoir Volume relationship for Katondwe reservoir, 24 February, 2015. (Source: Field Data)

The reservoir surface area was found to be 7,881 m<sup>2</sup> and the water volume was 10,714 m<sup>3</sup> (Table 5.4). The results in Table 5.4 have been plotted to produce hydro and sediment hypsometric curves. Figures 5.8a show a very close relationship between depth and reservoir area, and so is the relationship between depth and reservoir volume (Figure 5.8b). The current total storage capacity of Katondwe dam was found to be 10,714.88m<sup>3</sup> whereas, 35 years ago, the design storage capacity was 20,652 m<sup>3</sup> (Table 5.4). The Sediment deposition between 1980 and 2015 in Katondwe reservoir has resulted in a loss of approximately 9,937.12 m<sup>3</sup> (39.2%) of reservoir storage capacity.

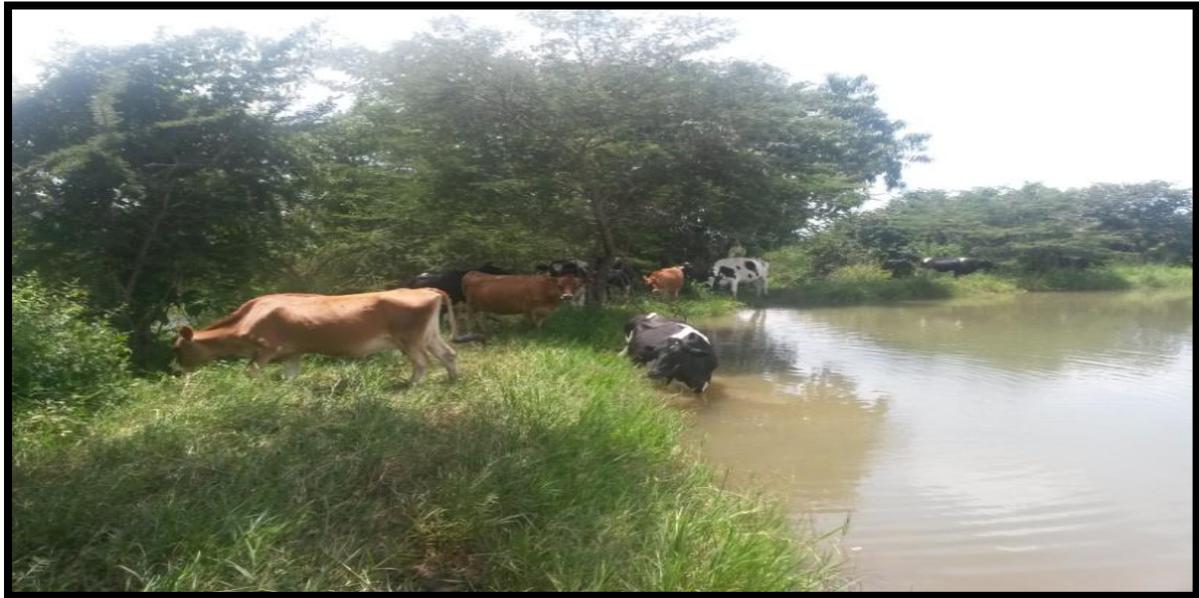
Figure 5.9: Morester dam used for livestock drinking, 8 March, 2015

During the study respondents reported that sedimentation affected mainly usage of small dams due to reduced water storage capacity. For instance, the loss in storage capacity at Lwiimba dam was negatively affecting irrigation and livestock watering. The dam quickly filled up with water at the onset of the rainy season since the dam bed has been raised due sedimentation. As a result, Lwiimba dam dries up in dry season. It was no longer able to conserve water for both livestock and irrigation throughout the year. This was also the case for Silverest dam where the loss of storage capacity was affecting irrigation. It was revealed that although the dam did not dry out completely in the dry season, the stored water during that time was not enough for pumping to the centre pivots for irrigation. Consequently, towards the dry season, irrigation was suspended so as not to deplete the water completely and reserve some water for livestock watering. Meanwhile, the loss of water storage at Morester dam (Figure 5.9) was said to have contributed to the abandonment of the dam for irrigation. The dam was longer holding enough for irrigation such that it was just used for livestock watering (Malilo Patrick, pers. com, 2015).

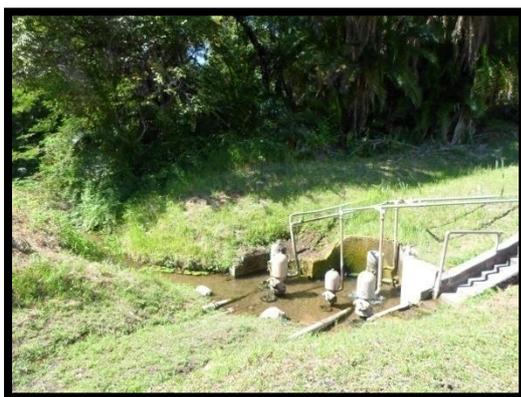
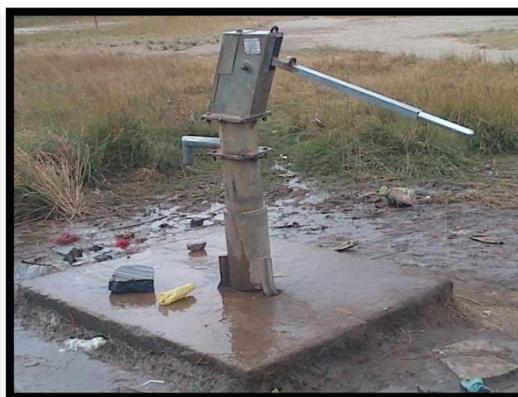
Figure 5.10: (a) Pressure pumps, pumping water from Katondwe dam and (b) Borehole hand pump supplementing water from the dam to Katondwe Mission for water supply, 24 February, 2015.

Katondwe dam was exclusively used for domestic water supply through the use of pressure pumps (Figure 5.10a), loss of storage capacity was posing a challenge to Katondwe Mission in the provision of water supply to Katondwe school and the Hospital. It was reported that due to low water storage, especially in dry season, Katondwe management faces challenges of adequately supplying water to these two facilities. As such, boreholes have been sunk to supplement the water supply from the dam (Figure 5.10b).
