ASSESSING THE USE OF EXFILTRATION PERVIOUS PAVEMENTS AS A BEST
MANAGEMENT PRACTICE FOR STORMWATER MANAGEMENT FOR LUSAKA
URBAN

A dissertation submitted to the University of Zambia in partial fulfillment of the requirements for
the award of the degree of Master of Science in integrated water resources management.

THE UNIVERSITY OF ZAMBIA
LUSAKA
(2020)

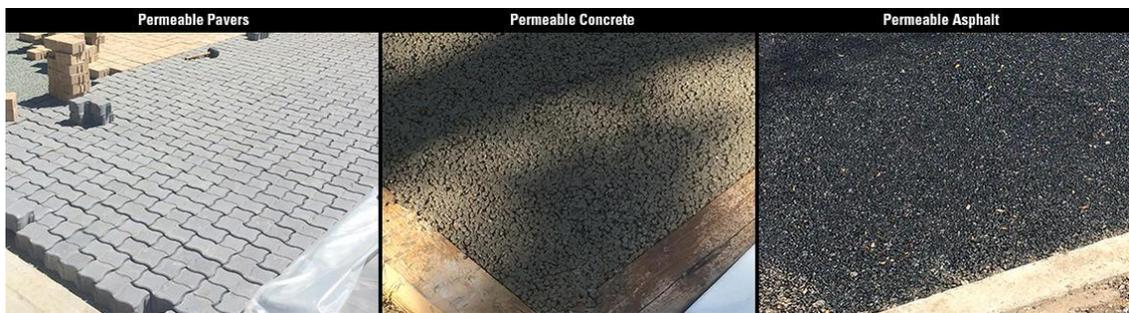
Figure 1: Types of pervious pavement systems. (Selbig and Buer, 2018).

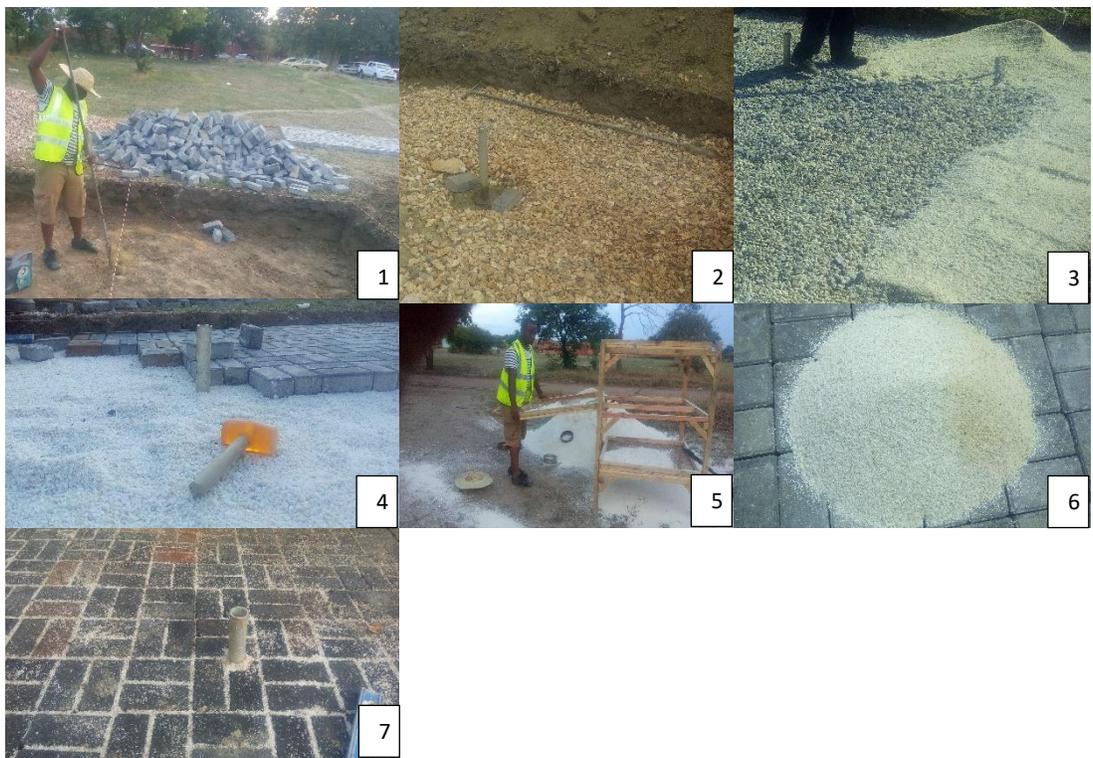
Figure 7: Installation of pavers after spreading the bedding layer.

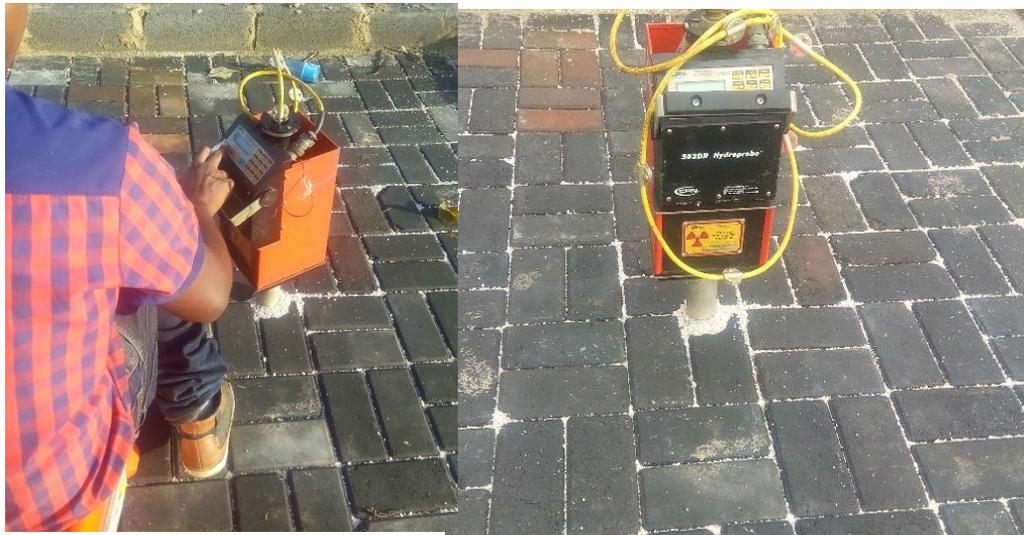
Figure 9: The gauge set to take moisture readings on the tube installed on the pavement system.

Storms events numbering 36 were monitored for contribution to the unsaturated zone through infiltration using the neutron gauge (See Figure 8 and 9). Daily moisture readings were done following rain storms for the whole period of the rainfall season in all the sites using access tubes. One access tube was installed on the pavement system. A second tube was installed in the natural environment for control. The moisture data collected during the rainy season was analysed for soil moisture changes in the soil profiles to determine quantities being contributed to the unsaturated zone by the pervious pavement system.

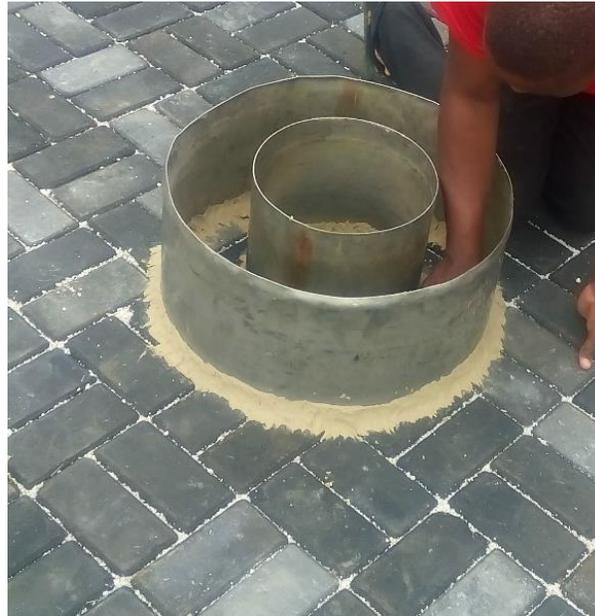
Figure 10: Installation of a double ring infiltrometer on the pavement system.

The average infiltration rate (IR) test was done on the installed pavement on the sites to determine the amount of stormwater which can infiltrate the system using the double ring

infiltrometer. A double ring infiltrometer was used so as to reduce lateral movement of water from the inner ring. The rings were set on the pavement and their base was sealed with plumber's patty to stop the lateral flow of water on the surface of the pavement (See Figure 10). This test was done on all the plots three weeks after installation and readings were taken from the floating ruler in the inner ring until all the water infiltrated. The test was conducted twice on each plot after a month.

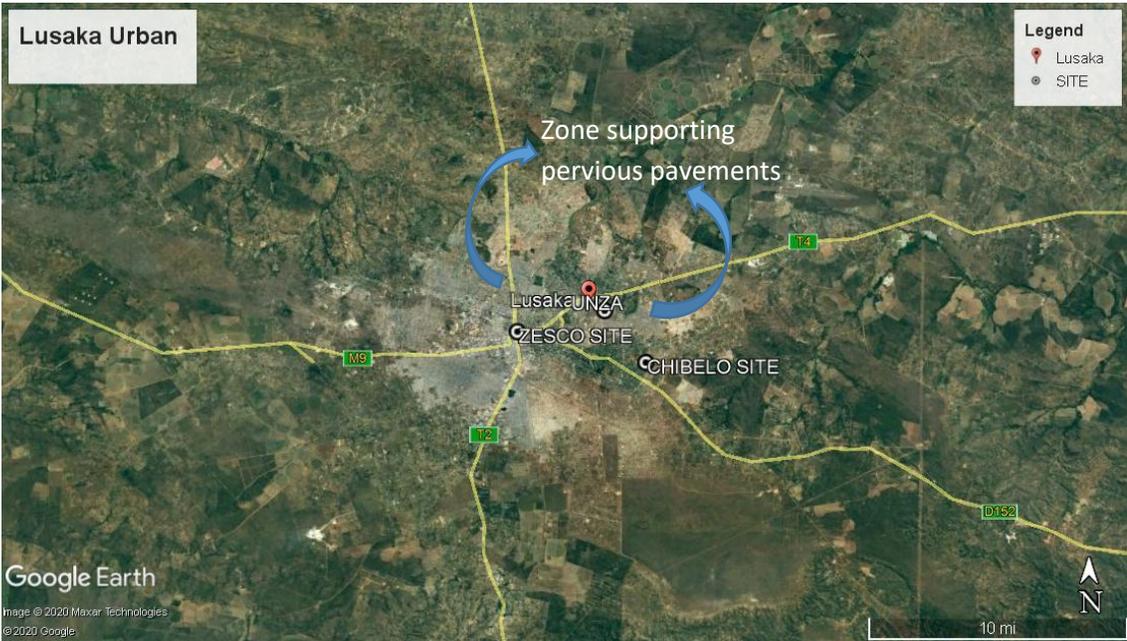
Figure 11: Central part of the urban supporting the use of pervious pavements [Source-google image 2020]

The northern and southern parts of the urban exhibited wide areas of rock outcrop due to the dominance of dolomite and schists formations on which the urban lies. The central eastern part of the urban had sufficient soil depth to support construction of full exfiltration pervious pavement. It is underlain by schist and quartzite formation (See Figure 11, 13 and 15).

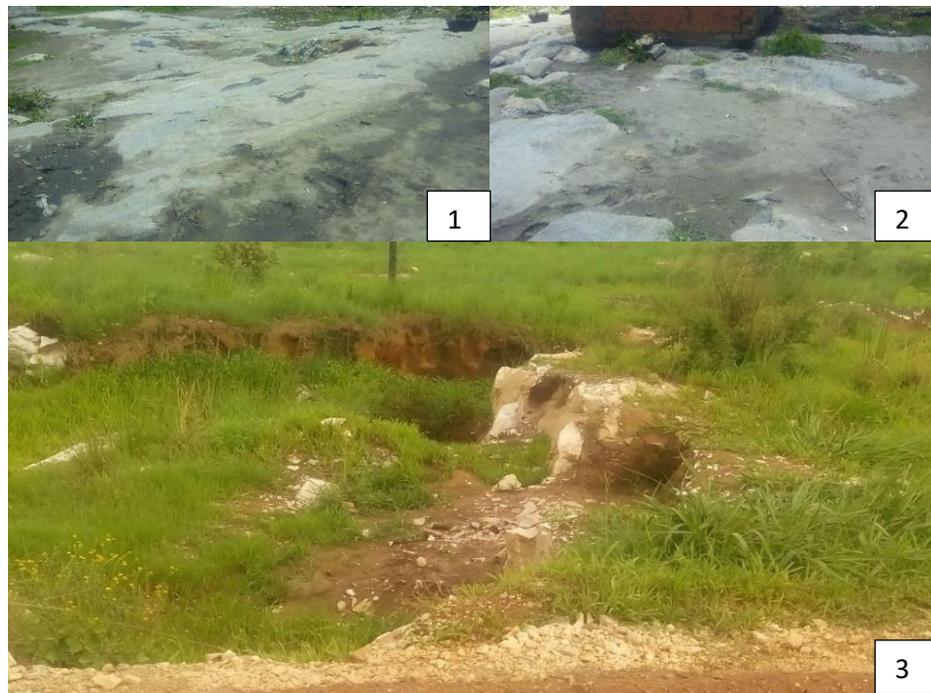
Figure 12: Wide areas of rock outcrop in the southern and northern parts of the urban

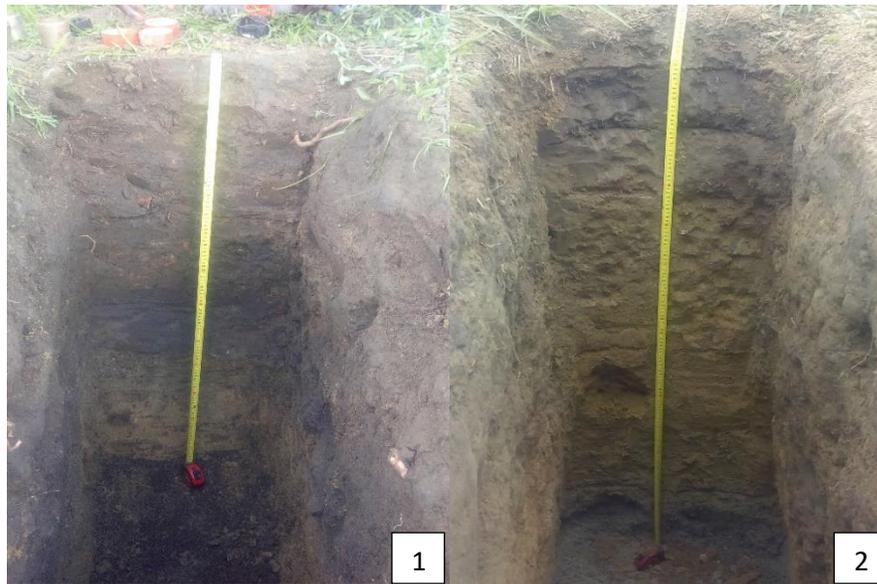
Figure 13: The central part of the urban exhibiting sufficient soil depth to support exfiltration pervious pavements.
