**SHARED WATERS, SHARED OPPORTUNITIES  
AND SHARED THREATS; THE CASE OF CHUNGA RIVER, LUSAKA,  
ZAMBIA**

**Submitted in partial fulfillment of the requirements for the Post-graduate  
diploma in Integrated Water Resources Management**

**The University of Zambia**

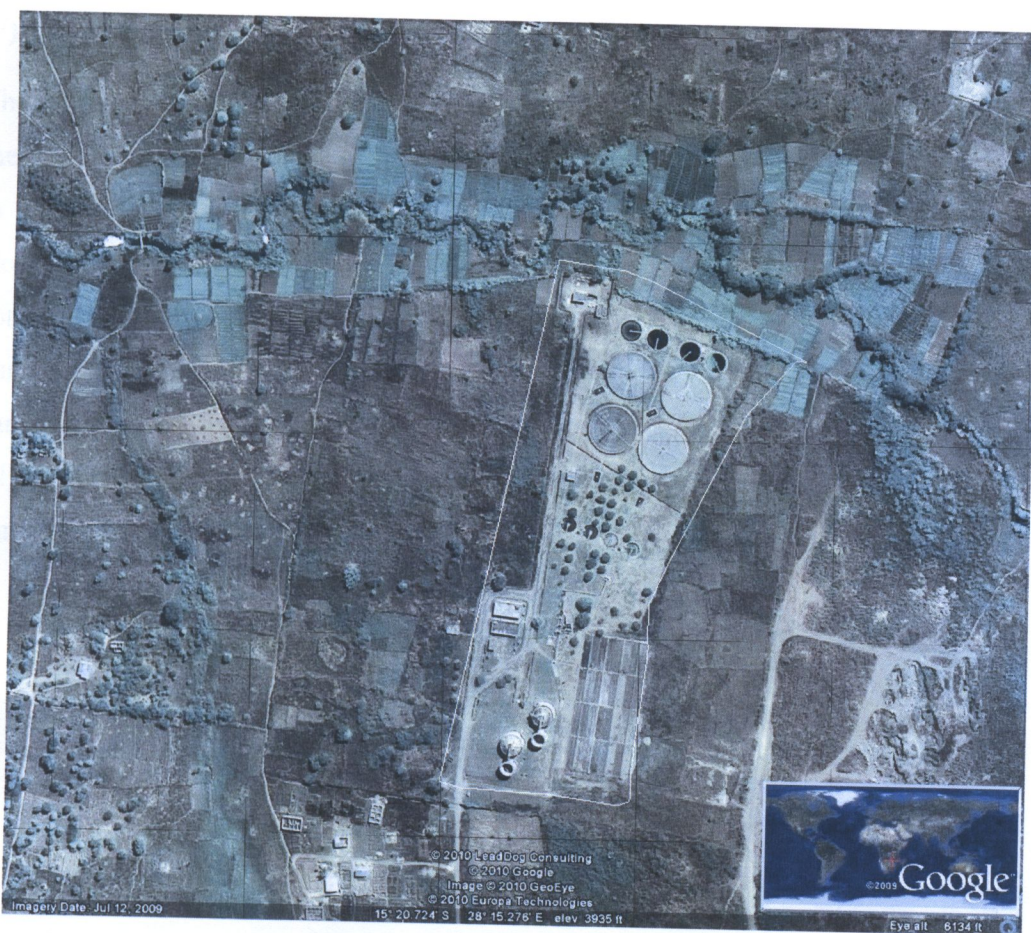
**Figure 1- 2: Aerial view of the location of the LWSC treatment plant and Chunga River in Lusaka, Zambia. (Source Google Earth)**

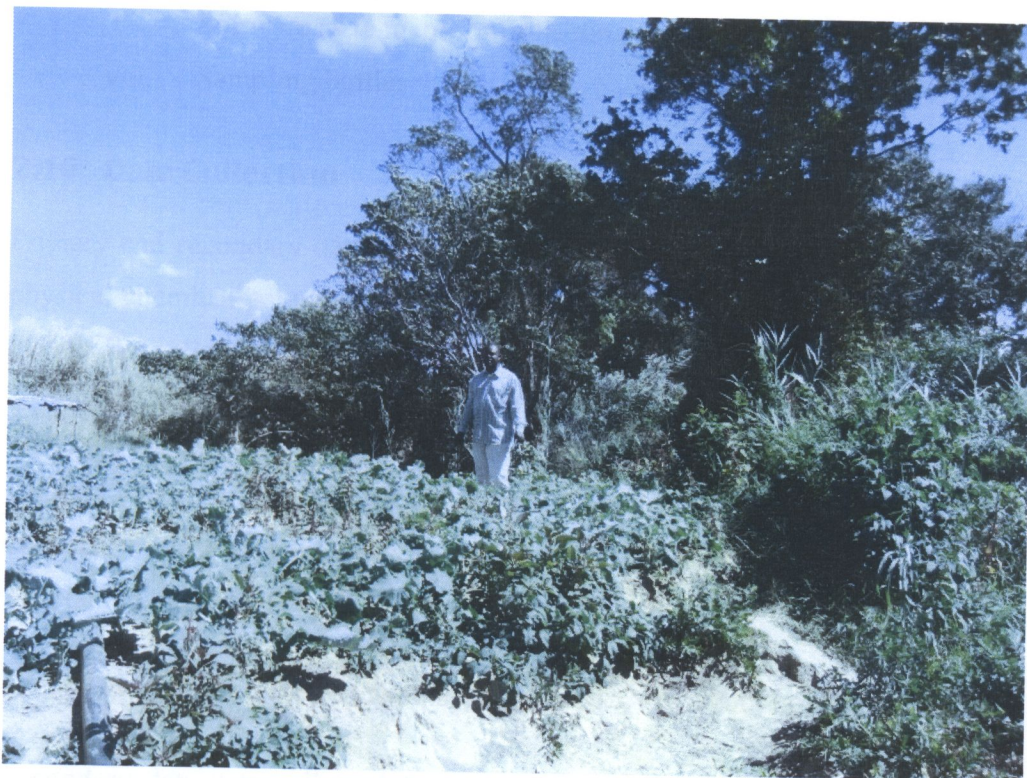
**Figure 2- 1: Agricultural activity on the banks of Chunga River at Rephidim institute in Lusaka**

A field reconnaissance visit was then set up in the month of December so as to select the sampling points so as to check the feasibility of sampling during the exercise. During the same period, interviews were conducted with the emerging farmers that line the river just beyond the LWSC Chunga Treatment Plant discharge point. The reconnaissance however for mapping potential sites for the set up of dams was however not done. This was due to lack of software (Digital Elevation model) and resources to map out ground-truthing events. A questionnaire was nevertheless prepared for collection of qualitative data on the types of farmers, crops grown and the extent of this practice.

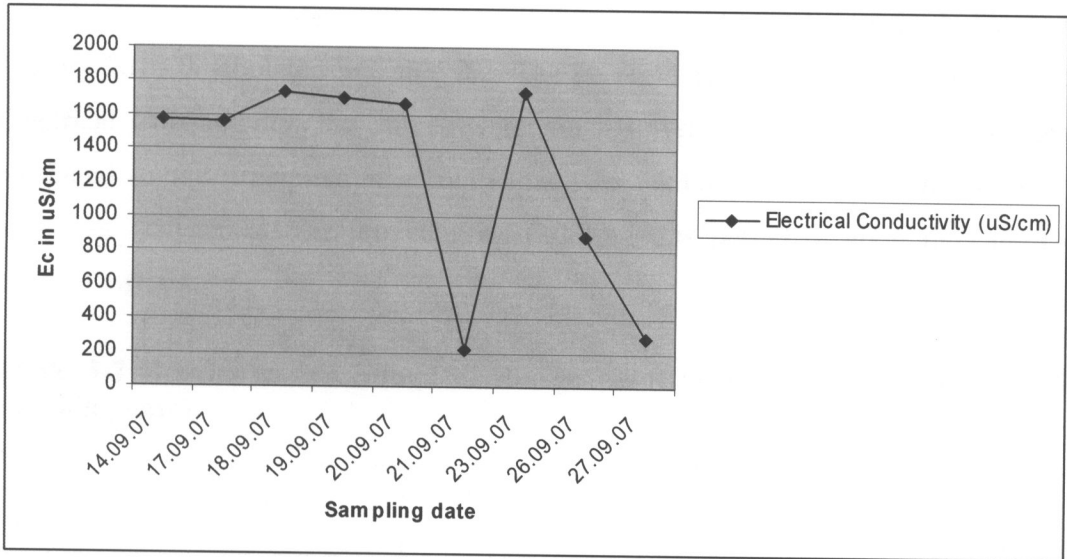
The Electrical Conductivity (EC) values in September 2007 as reflected in Table 3-2 are illustrated in Figure 3-2. Apart from the outliers on 21<sup>st</sup> and 27<sup>th</sup> September 2007, the EC ranges are above 1400 $\mu$ S/cm. The ECZ standard for is 4300 $\mu$ S/cm. These values are within the statutory limits.

**Figure 3- 2: Electrical Conductivity of Water at just after LWSC Chunga Discharge point in September 2007, Lusaka, Zambia.**

Electrical Conductivity (EC) estimates the amount of total dissolved solids or ions in the water. This is controlled by factors such as river geology and nature of the effluent discharge. The higher the Electrical Conductivity the more dissolved solutes are likely to be found in the water. This is indicative of pollution load in the water. (Figure 3.2)

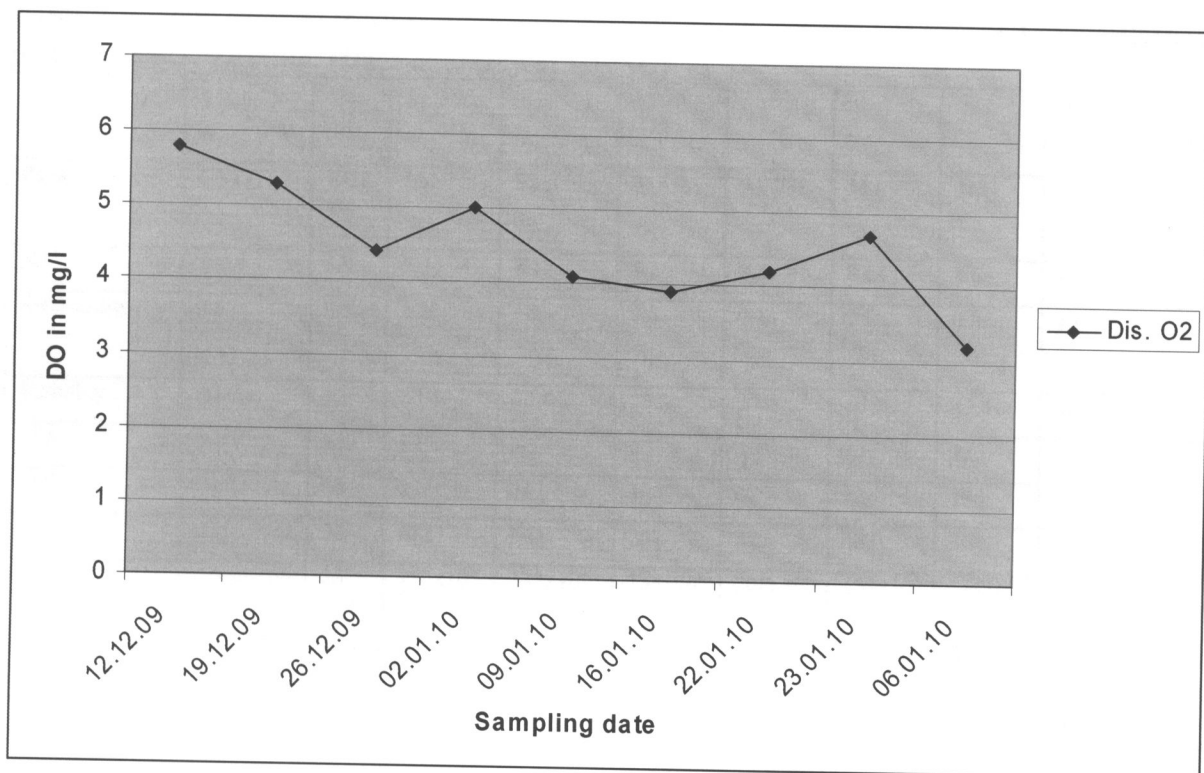
The Dissolved Oxygen values show a trend (Figure 3.6) that is higher than those in September 2007 sampling campaign (compare with Figure 3.3). Again this confirms the observation in Table 3.4 that precipitation during this period induces dilution of water in the rivers which in turn improves the Dissolved Oxygen in the surface water. However, it is observed that only three out of four readings met the standard for statutory regulation indicating that the quality of the water is poor at this point in the river channel.

**Figure 3- 6: Dissolved Oxygen values of water just after LWCS's Chunga discharge point in Dec/Jan 2009/2010**

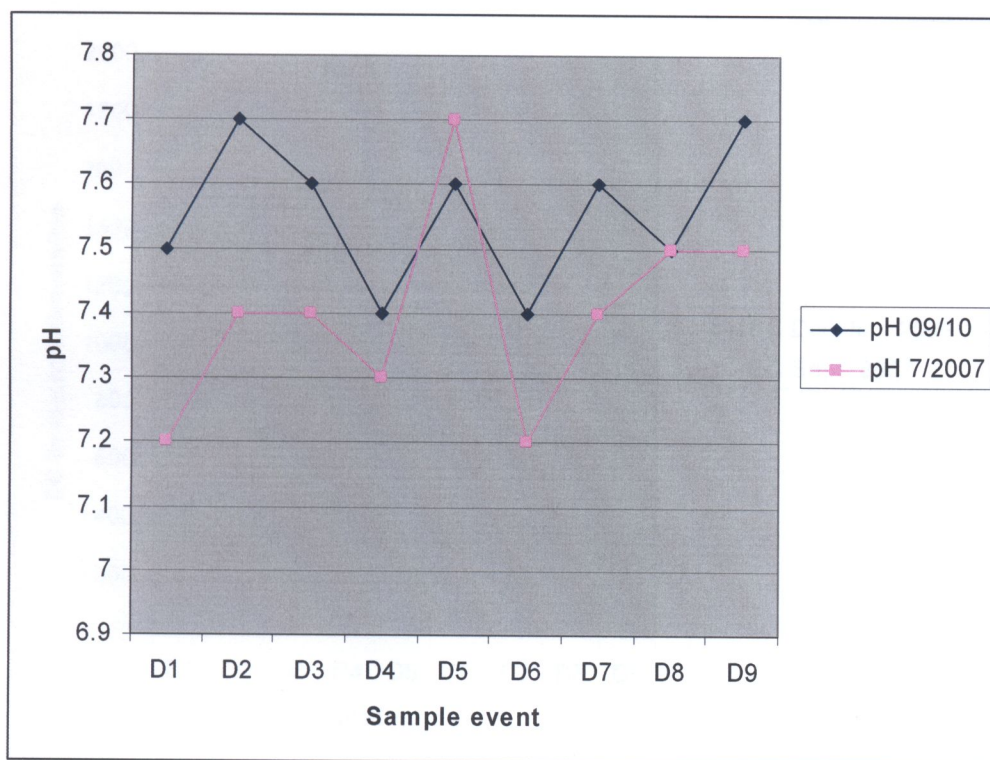
The pH standard is 6.5-8.5 for effluent discharges. The pH of the water exhibited ranges that are close to neutral over the two different seasons. It is also noted that the pH was above seven but below 7.7. This presents a relatively good result on this particular parameter as most aquatic organisms will usually be comfortable at this pH. Between 2007 and 2010, the types of human activity for the study area has relatively remained constant hence the assumption that sewer discharge has remained the same in the general. It is noted that the pH remained between 7 and 8 regardless of the period of the year in the river channel (Figure 4.1).

**Figure 4- 1: Comparison of pH values for Chunga River just after the Discharge point for September 2007 and Dec/Jan 2009/10**

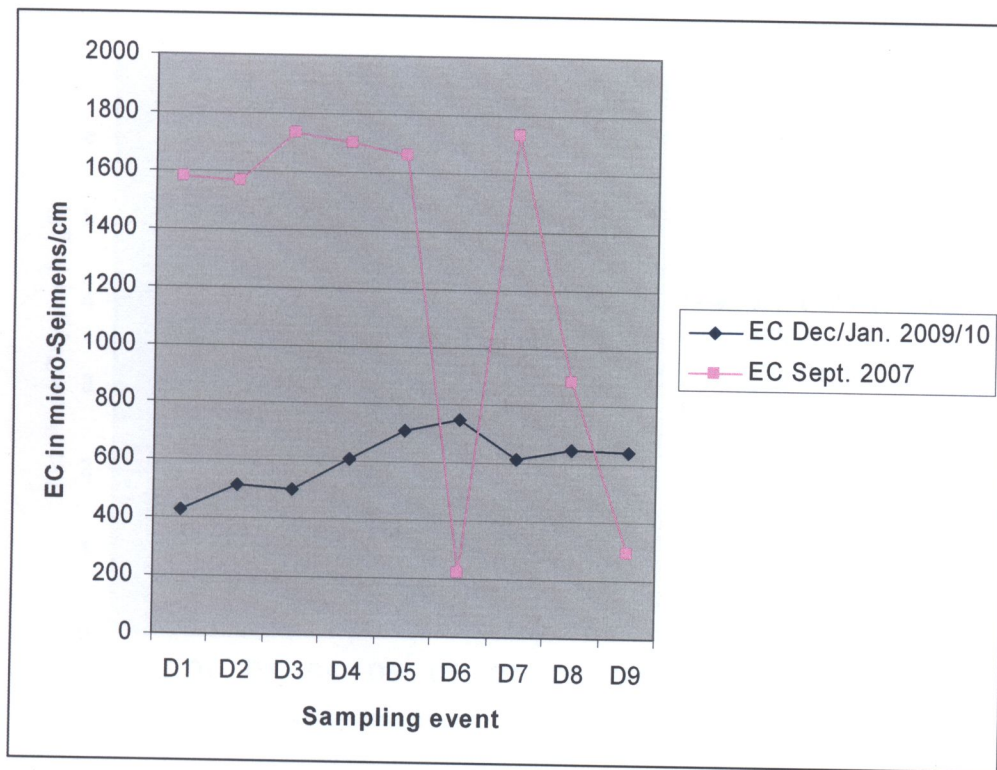
The Electrical Conductivity however exhibited stark variations between the two reference points (Figure 4.2). Although it was within the ECZ effluent standard threshold, it was in the higher ranges in the in the dry than in the rainy season. Despite the two outliers (caused by instrument faults) in September 2007, the reason for this can be attributed to the dry weather where there is no precipitation to dilute the effluents. From this we can deduce that during the rainy season, effluent solute concentration is reduced due to the dilution effect of precipitation as well as groundwater intrusion from the ground. The Electrical Conductivity also showed a gradual drop as the river moved further downstream. For Example, the EC at Chunga in April averaged around 1133.5  $\mu\text{S}/\text{cm}$ , while at Rephidim Institute (20km downstream) averaged around 1130  $\mu\text{S}/\text{cm}$  (Table 3.4). This shows the river's self purification potential as the number of solutes dissolved in the water reduce the further you go from the discharge point. Groundwater intrusion is also a contributing factor in this self purification capacity.

**Figure 4- 2: Comparison of EC values for Chunga River just after the Discharge point for September 2007 and Dec/Jan 2009/10**

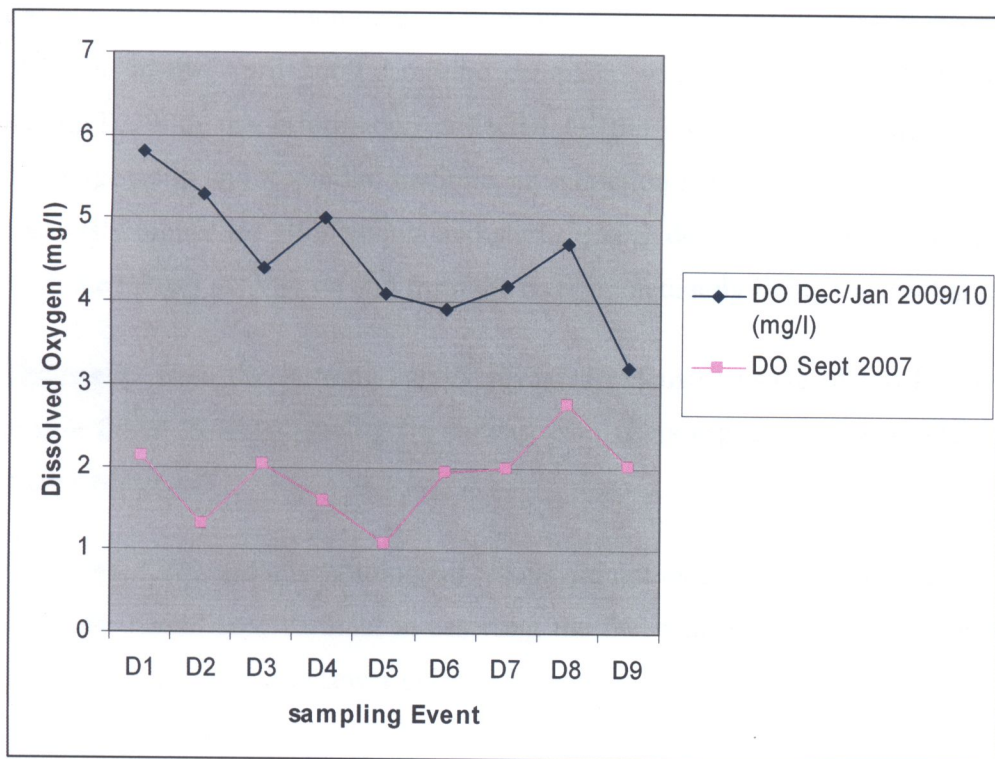
The ECZ standard for effluent discharge for Dissolved Oxygen is 5.0 mg/l. The results from the physical-chemical tests revealed that the level of Dissolved Oxygen in dry season remained below 3.0mg/l. The result for the rainy season (Dec/Jan 2009/10) consistently exhibited a higher level of Dissolved Oxygen than the ones in summer 2007 (Figure 4.3). This poses a threat to aquatic life especially at the discharge site as it would suffocate out most aquatic organisms. Also this result denotes that within the effluent discharge, there exists a lot of oxidizing agents among them biological and chemical compounds.

**Figure 4- 3: Comparison of DO values for Chunga River just after the Discharge point for September 2007 and Dec/Jan 2009/10**
