1.0 INTRODUCTION

1.1 Problem Statement

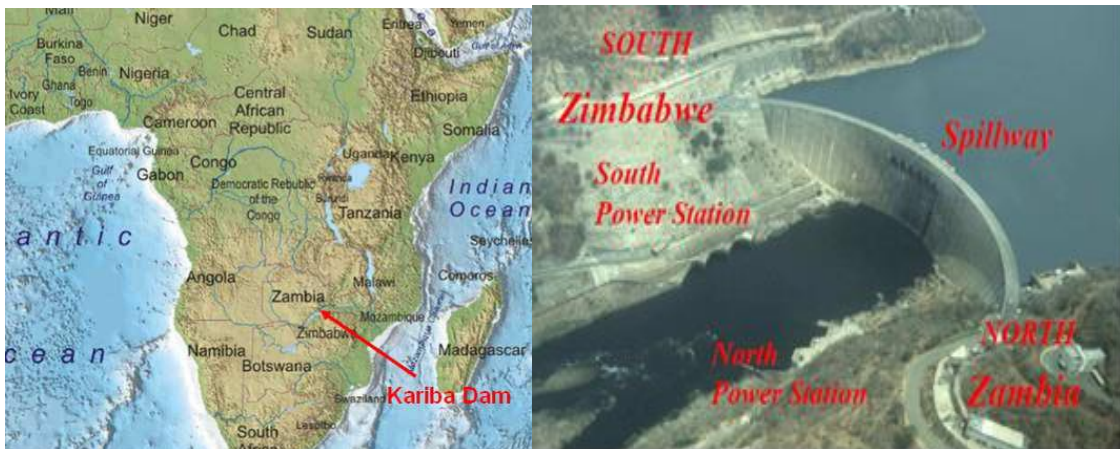
Figure 2.1: Kariba Dam location (left) and general view (right); courtesy of ZRA

The Kariba Dam is located ($16^{\circ}31'18''$ S, $28^{\circ}45'41''$ E) almost midway down the Kariba Gorge of the Zambezi river basin on the border between Zambia and Zimbabwe. It is a double curvature concrete arch designed by a French firm called Tractebel Engineering, and was constructed between 1956 and 1959. It has a 128-meter high wall, crest width of 13meters, 24meters base width and 618 meters long wall. It created then the world's biggest man-made reservoir which impounds about 181 billion cubic meters of water. Its owner, Zambezi River Authority (ZRA) was established as a corporate body through parallel parliament legislations of Zambia and Zimbabwe in 1987. It feeds water to two underground hydropower stations located on the North bank in Zambia and on the South bank in Zimbabwe with a combined capacity recently increased to 1470MegaWatts (Coyne and Bellier, 2011).

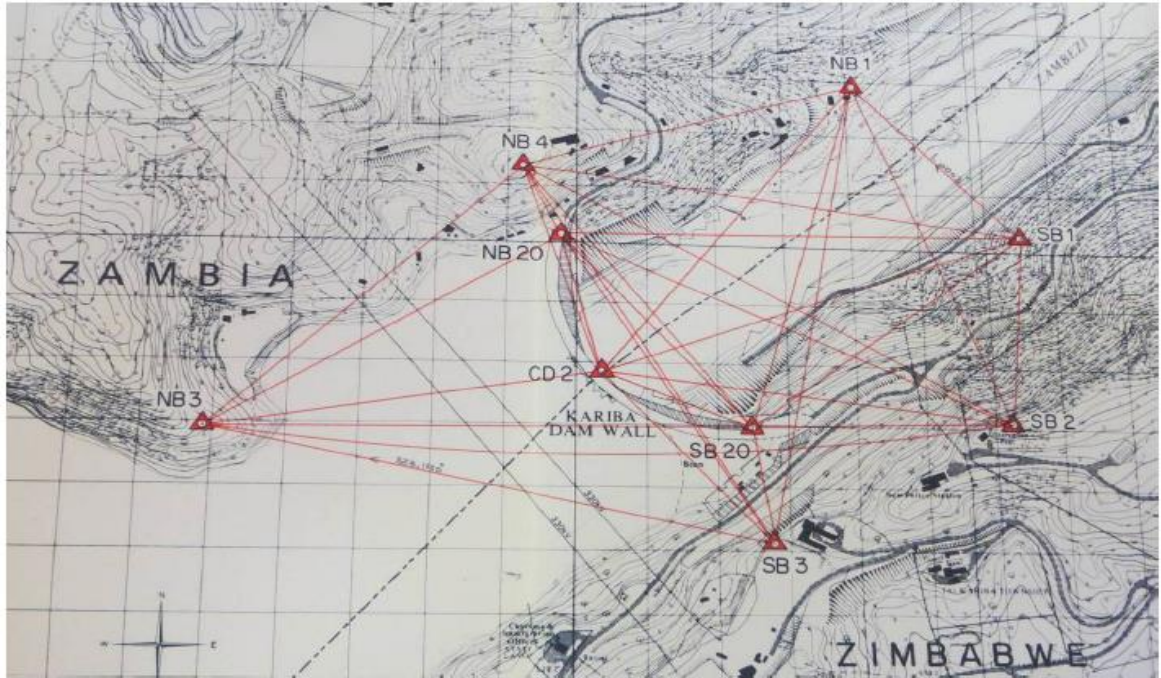
Figure 2.4: Primary Geodetic Control Points against which deformations are measured; courtesy of ZRA

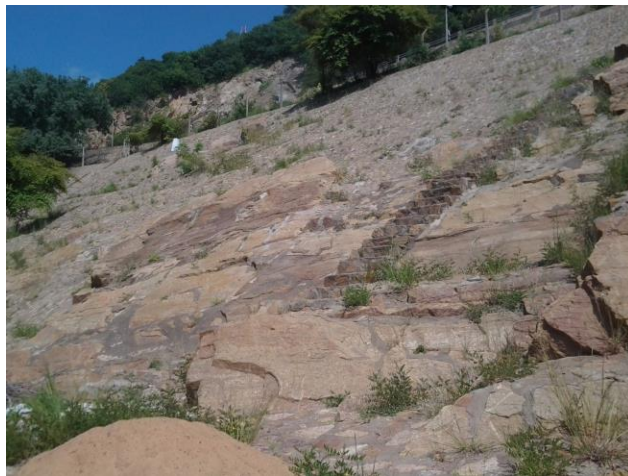
1. Drilling of shafts and adits to improve the underground water drainage system
2. Removal of surface micaceous bands and weaker material and replacing the same with concrete as shown in figure 2.11 below to reduce water ingress into the slope which would trigger more landslide.

Figure 2.11: Stone-pitched slope of the South Bank at Kariba Dam; Courtesy of ZRA

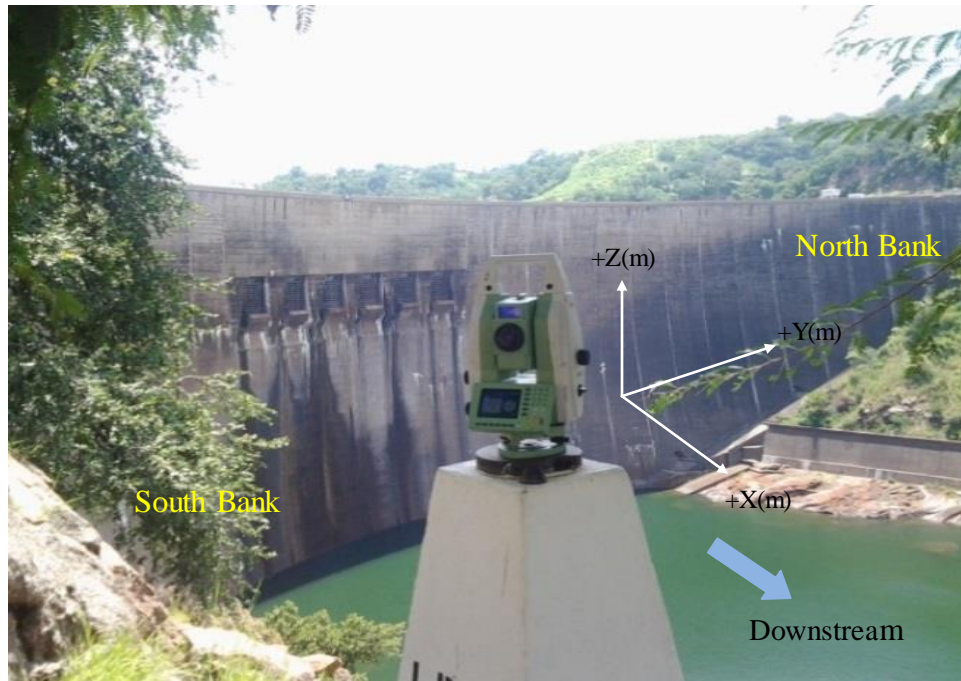
In order to understand the sketch, remember the local coordinate system used for Kariba Dam monitoring which is shown in figure 3.3 below.

Figure 3.3: Kariba Dam Local Coordinate System orientation: Courtesy of ZRA

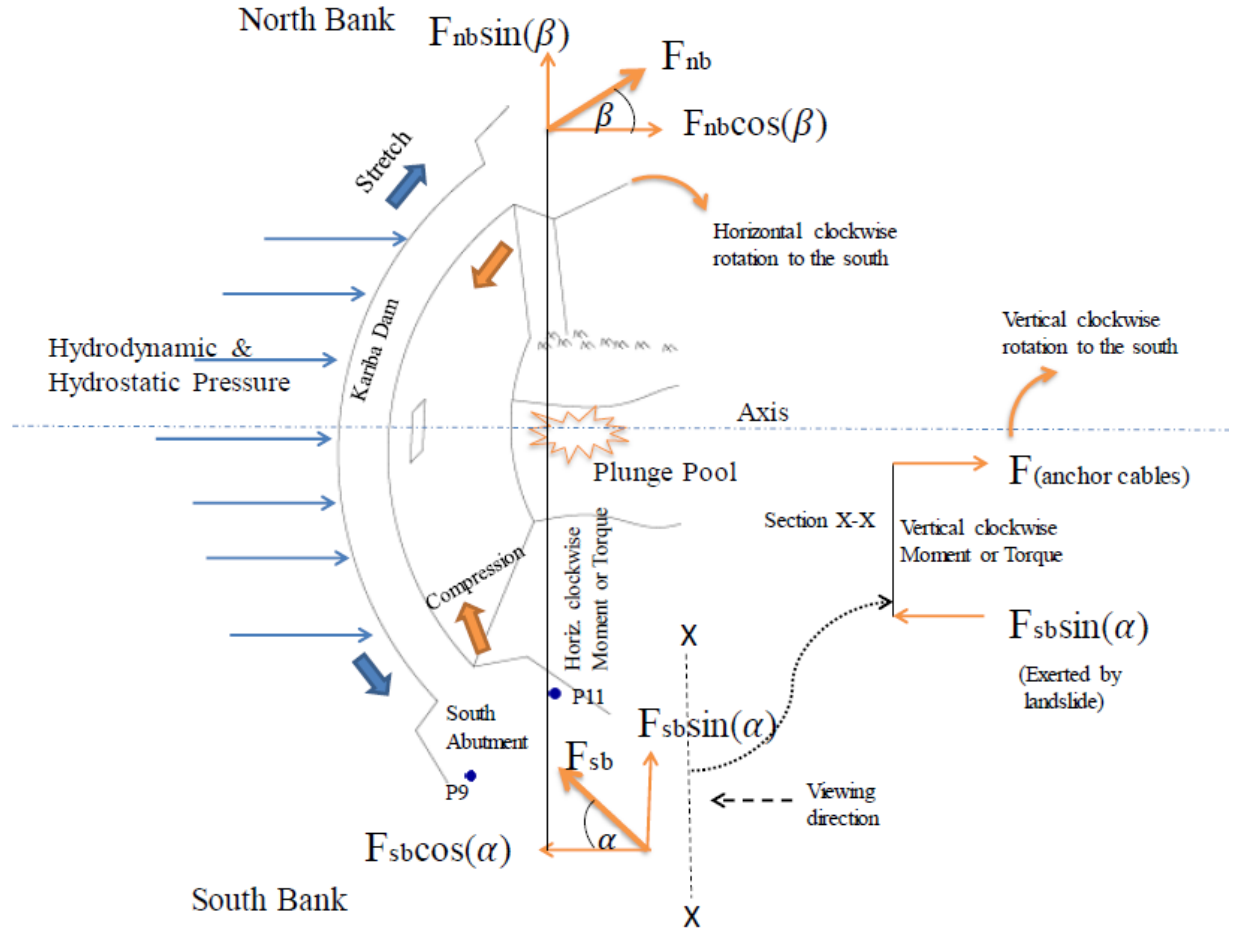
Note: The thrust here is focused on explaining the source of the northward translational and clockwise rotational movements of the dam arch. It is already known that hydrostatic and hydrodynamic forces were taken into account at design stage; hence they are not a threat in this case to the dam stability. As such, it can be assumed, from the geometric distortions of the dam, that the strange dam behavior cannot be attributed to the static water pressure. Thus stressing on the hydrostatic and hydrodynamic was not necessary; just showing them on the free body diagram sufficed.

Figure 3.7: Illustrative Free-body Diagram of the Kariba Dam arch (not to scale)

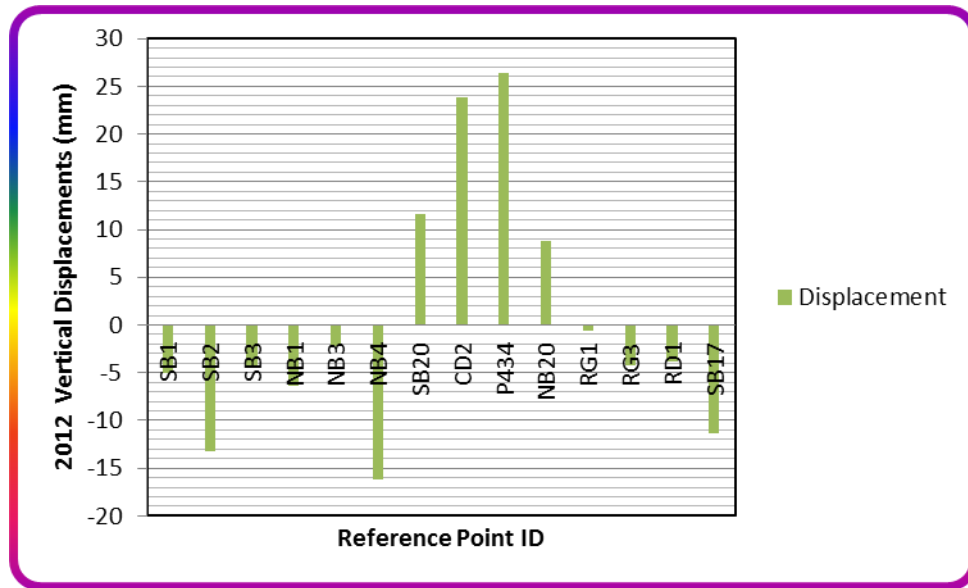
To analyze the sinking behaviour of the control pillars, the vertical displacements of the control pillar residuals in table 3.2 were plotted as shown in the bar chart (figure 3.8) below.

Figure 3.8: 2012 Vertical displacements of monuments

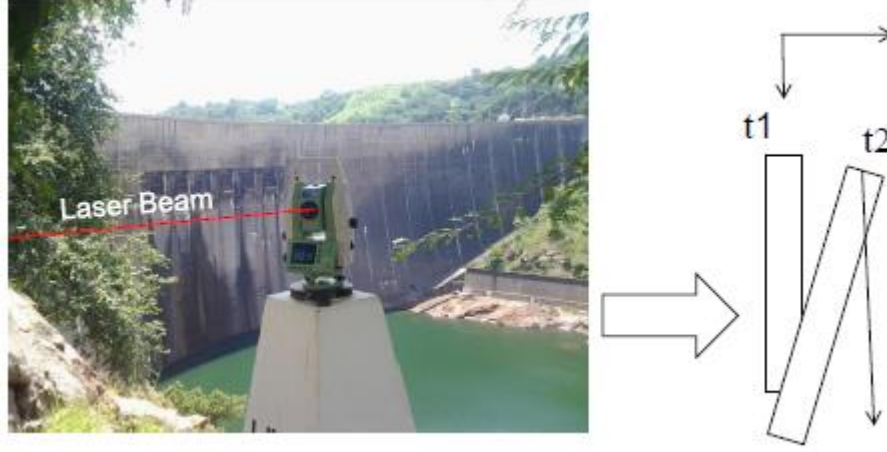
$(x_{sb17} + \sigma_x, y_{sb17} + \sigma_y, z_{sb17} + \sigma_z)$ and $(x_{nb1} + \sigma_x, y_{nb1} + \sigma_y, z_{nb1} + \sigma_z)$, where σ is a drift in x, y and z; **Note:** The drifts of SB17 are different from those of NB1 at time t_2 , and from the rest of the control points in the network, thus the *positional error inherited is not one constant*.

Figure 3.16: Total Station (left) mounted on unstable control point, SB17, (right); courtesy of ZRA

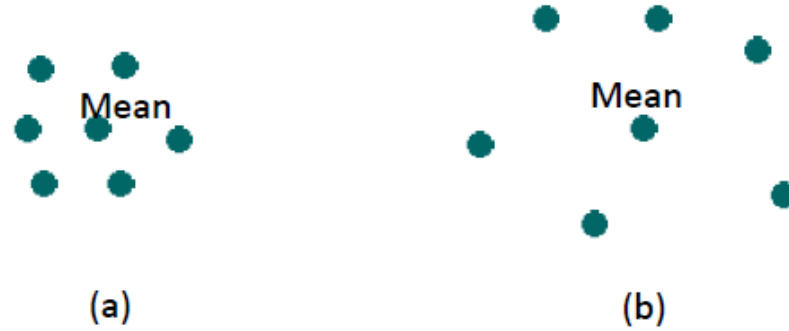
Figure 3.17: The scatter plots obtained at t_1 (a) and time t_2 (b)

In the above illustration, a Total Station set up on a reference point at time t_1 gives coordinates of the observed point as a scatter plot (a) in figure 3.17 below, because the coordinates for the same point will not remain the same due to errors beyond human control.

During data processing, the measurements are averaged to get the mean position of the measured point which is used in the network adjustment using least squares method.

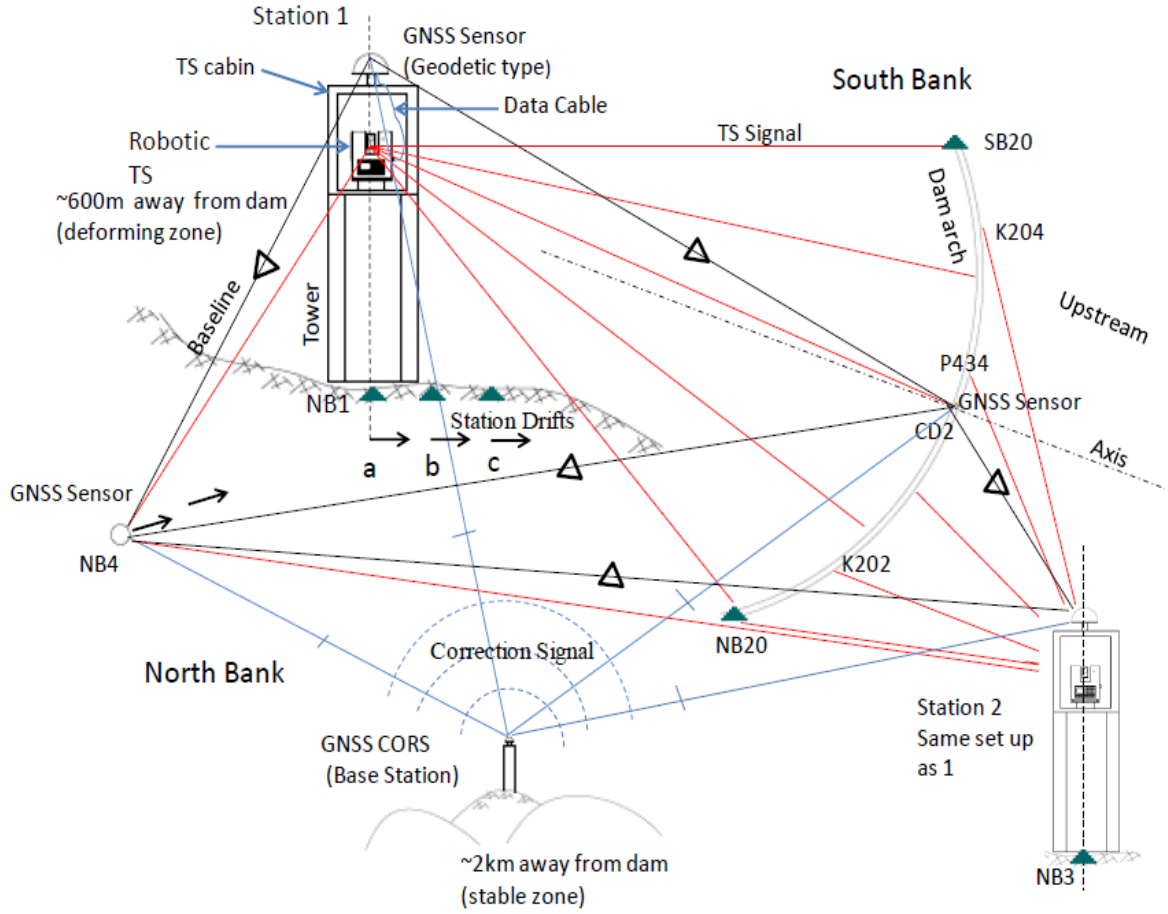
- The base station GNSS CORS outside the deforming zone is meant to calibrate monitoring stations, 1 and 2, through a correction signal
- Station 1 is designed to monitor landslide, dam arch drifts and rotations on the downstream side
- Station 2 is designed to monitor upstream arch geometric deformations illustrated on a vector map and arch geometric status drawings (see attached drawings 1, 2, 3 and 4 in the Appendix C).

Figure 4.2: Geodetic deformation monitoring system design for Kariba dam

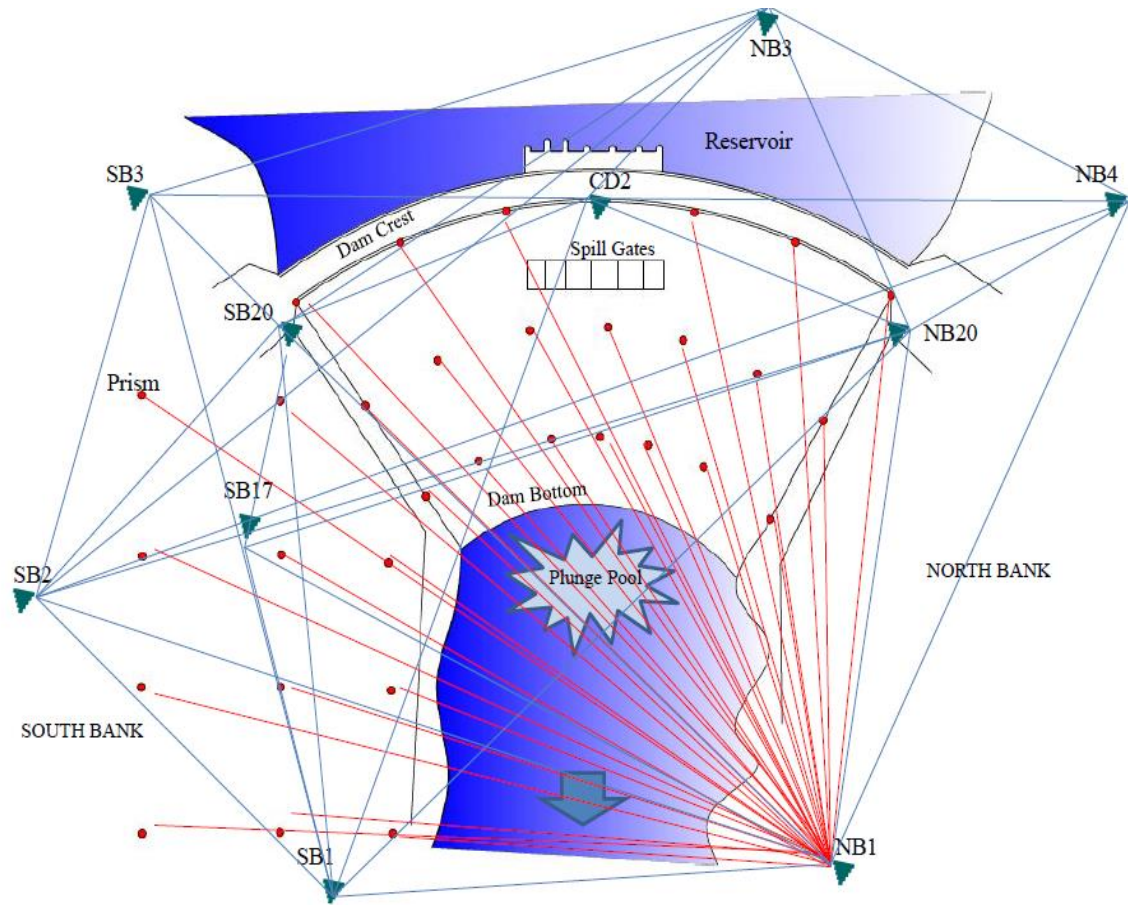
The prism array concept is illustrated in figure 4.4 below, although not all the prisms are shown in the sketch for clarity purposes.

Figure 4.4: Prism array for Kariba Dam monitoring

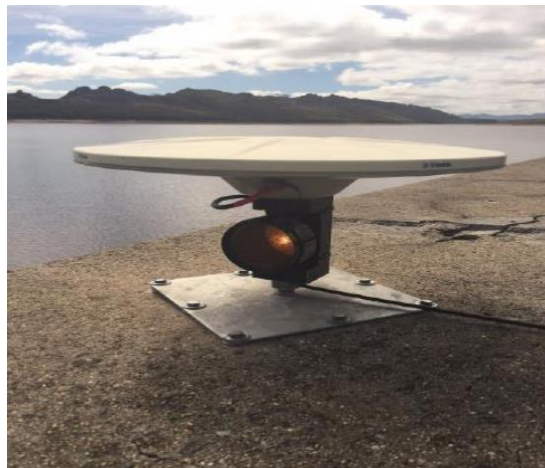
The GNSS monitoring points are all co-located with prisms as well as GNSS antennas as shown in figure 5.1 below.

Figure 5.1: Co-located GNSS receiver with Prism; Courtesy of Trimble

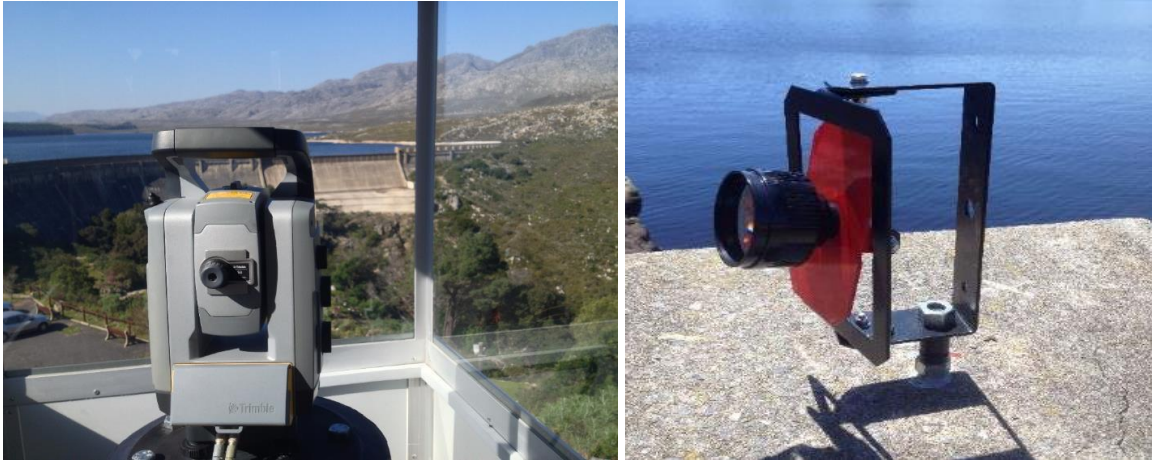
The S8 Robotic Total Station (RTS) is an optical instrument that measures angles and distances to reflective targets (prisms) from a known location which is also being monitored through the GNSS receiver mounted on top of its Cabin roof, with reference to the zero-order GNSS base station. From these measurements coordinates of the targets are calculated to millimeter precision. See set up below of a GNSS receiver, S8 TS and a prism.

Figure 5.2: *S8 RTS (left) in its Cabin and target prism to the right; courtesy of Trimble*

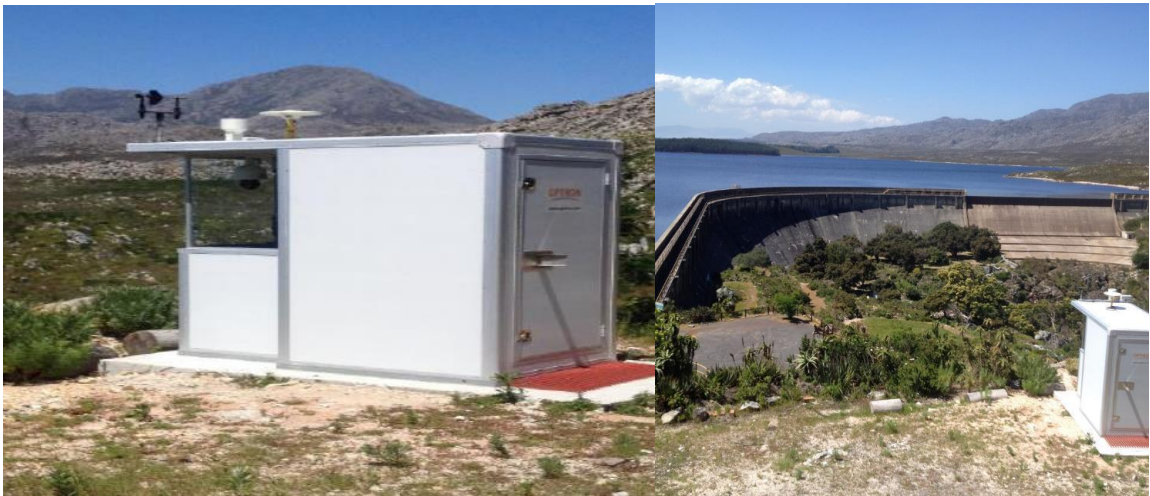
Figure 5.3: *Protective cabin, housing the S8 total station as well as a GNSS receiver on top with the weather station (left) on the cabin roof; courtesy of Trimble*

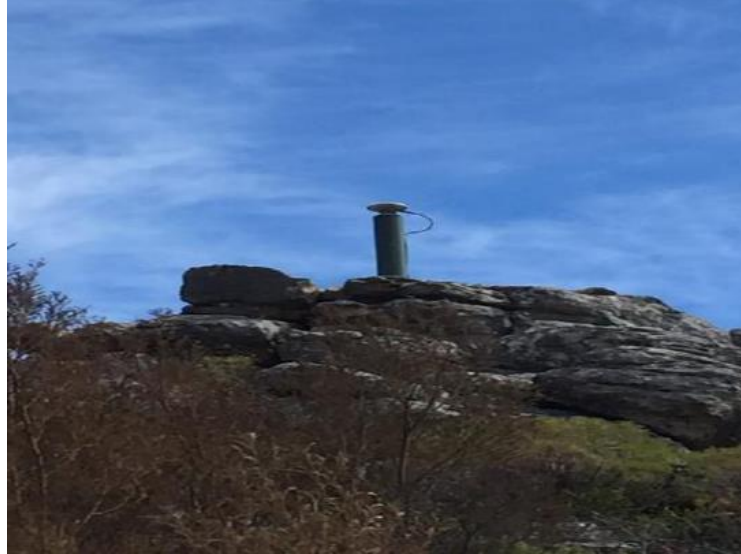
Figure 5.4: Shows the GNSS Base Station; courtesy of Trimble

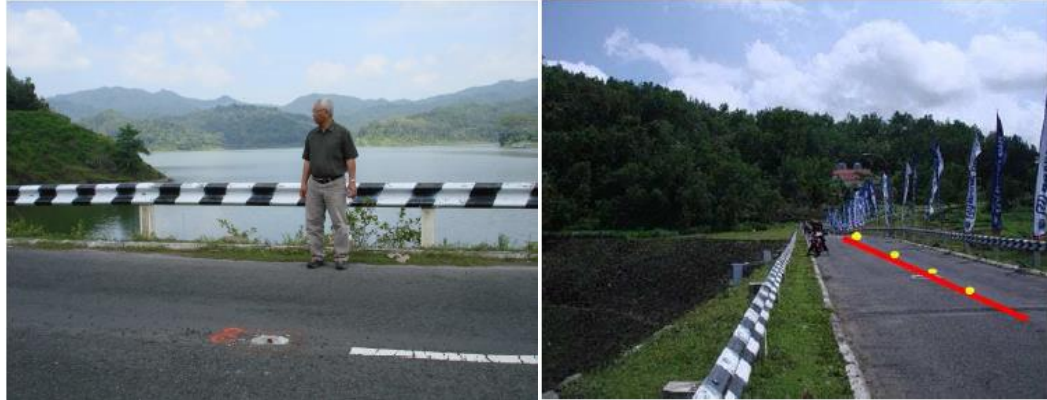
Prism installation at Sermo Dam

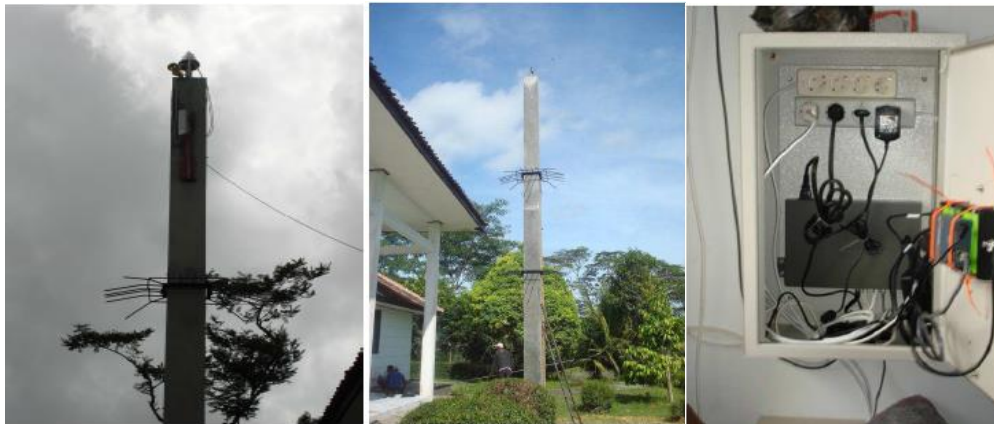
GNSS CORS receiver type: Leica GRX1200+ and antenna CHOCK RING (GNSS Antenna with Dome, geodetic type)

GNSS CORS at Back sight station

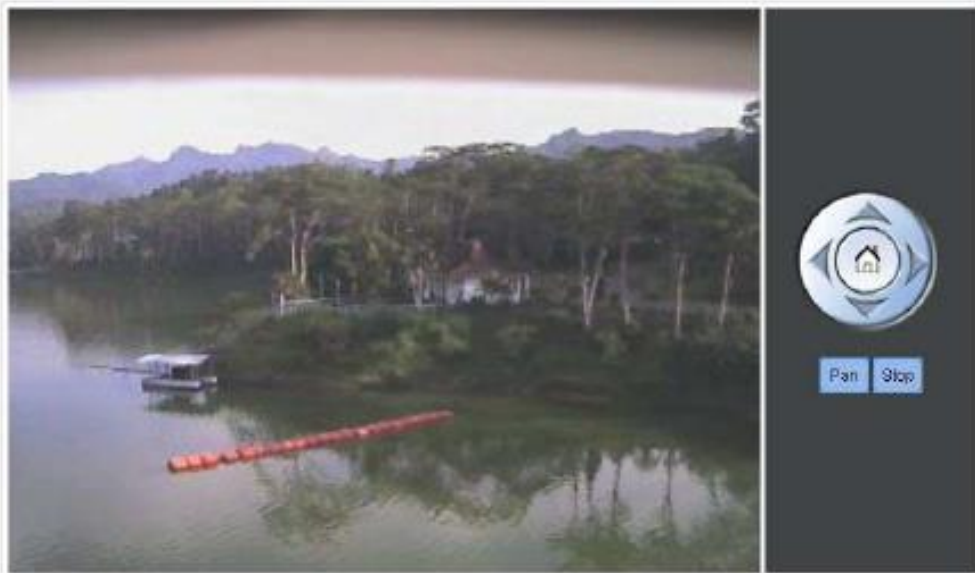
Sensors of Tilt, Zoom digital IP Camera (CCTV)

(a) CCTV presentation of situation

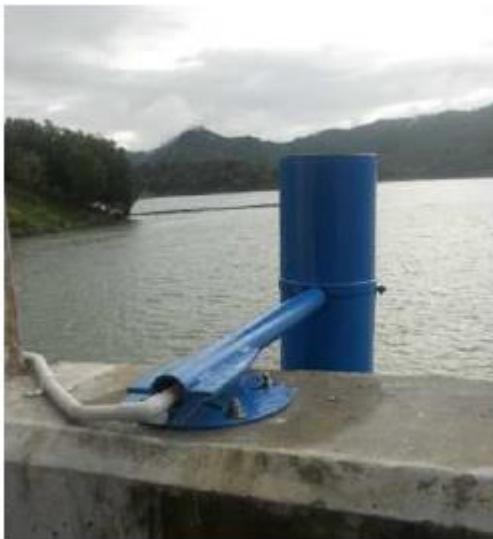
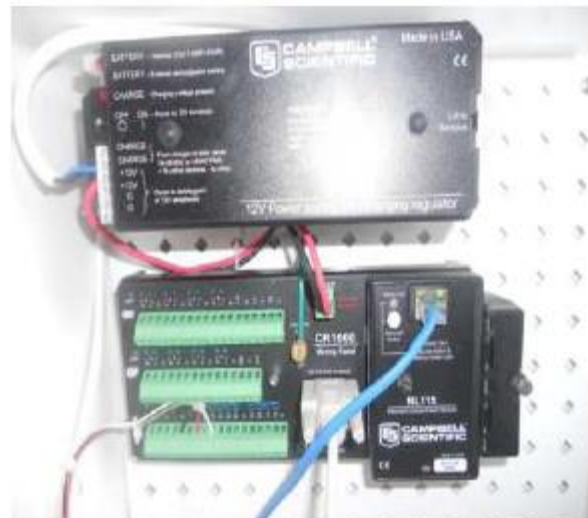
Figures (b) and (c); Automatic Water Level Recording (AWLR)
