# **CONSEQUENCES OF INEFFECTIVE PLANNING ON THE RESIDENTS OF KANYAMA SITE AND SERVICE**

Project report submitted to the Department of Geography at the University  
of Zambia in partial fulfillment of the degree in Natural Resources.

***OCTOBER 2004.***

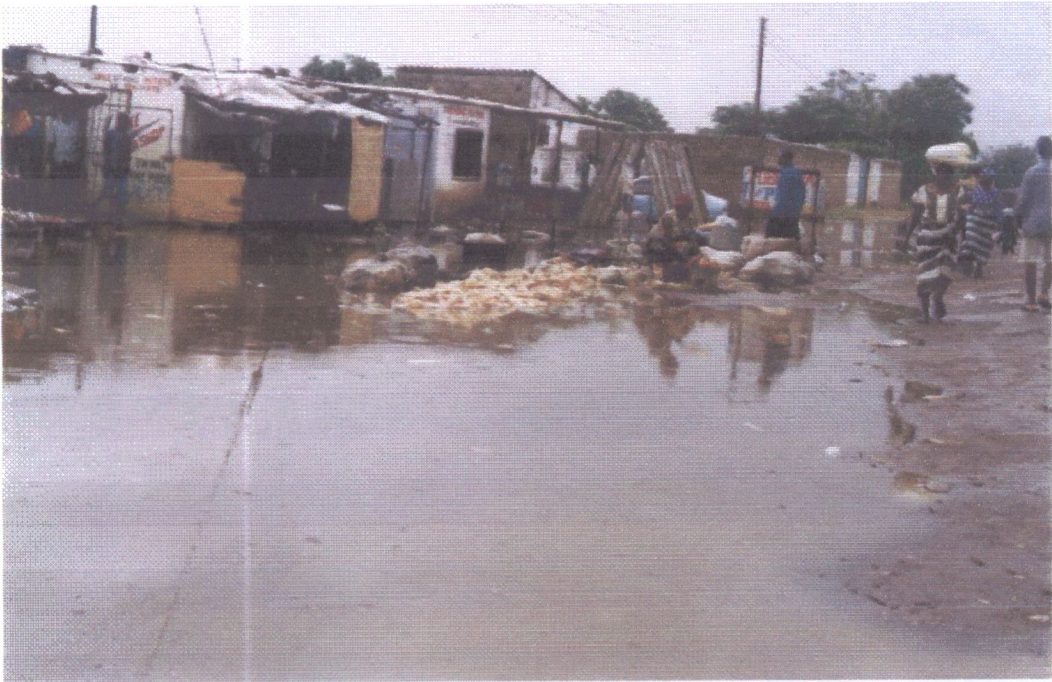
**Plate1; showing flooding at Pamodzi market in Kanyama site and service**

Figure 5 show that most of the respondents have experienced the occurrence of floods and the plates below show some of the areas during times of floods. These photos were taken on 14<sup>th</sup> February 2004

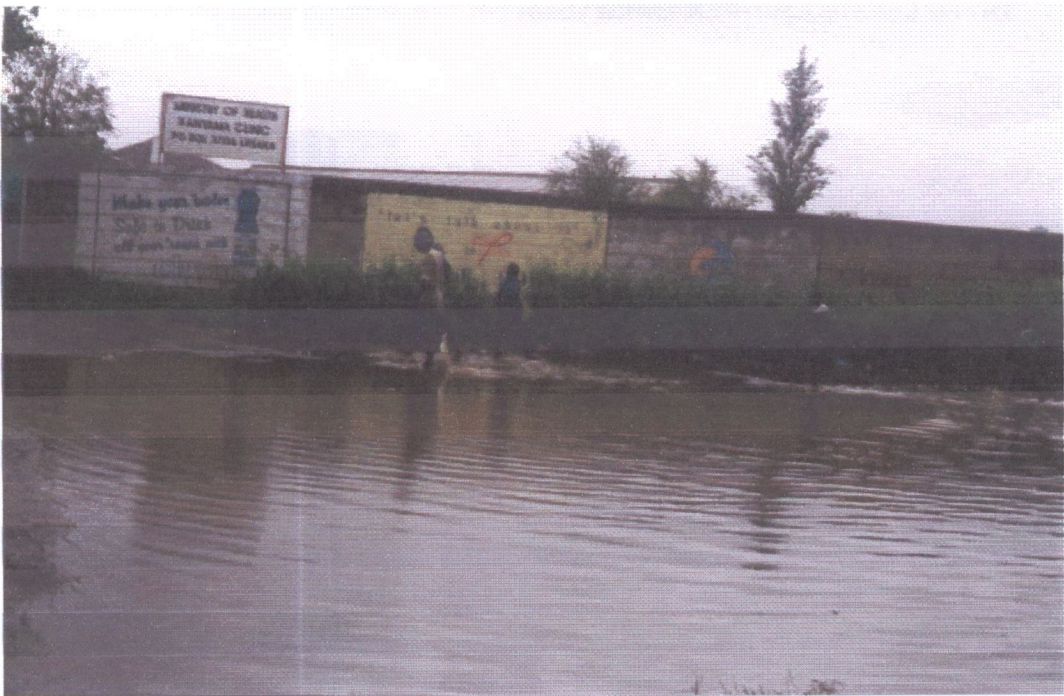
**Plate2; showing flooding near Kanyama Clinic.**

within the settlement (Plate2). On the other hand, those who use motorized vehicles complain of damages to the vehicles. Plate 3 shows vehicles on flooded road. However, transport to and from town is not a problem since the main road (Los Angeles) is tarred.

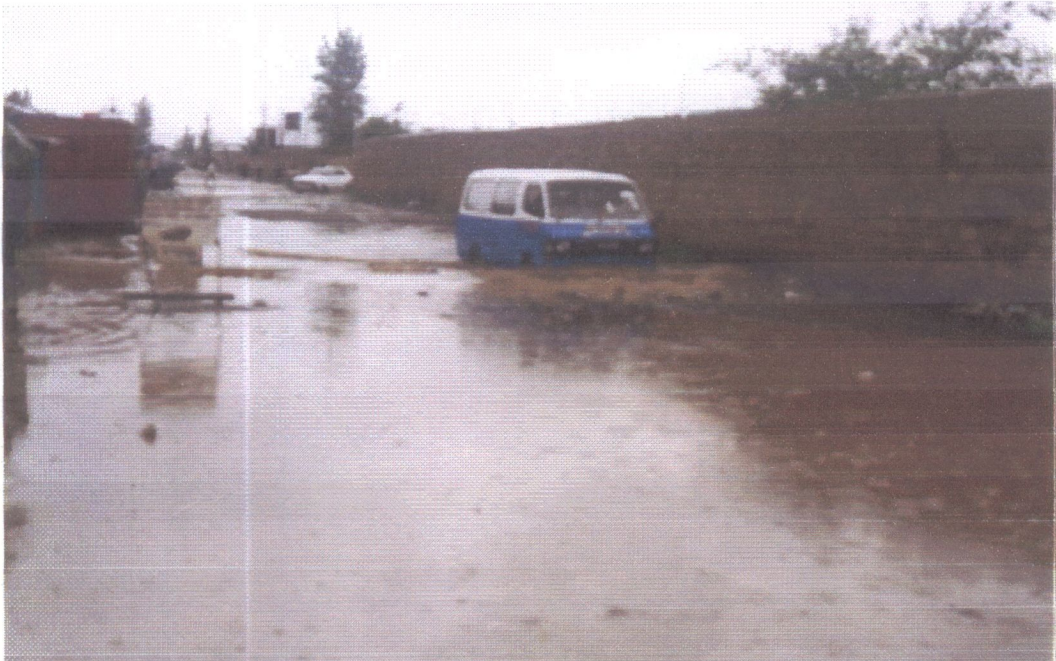
**Plate3; showing flooding on one of the roads within Kanyama site and service**

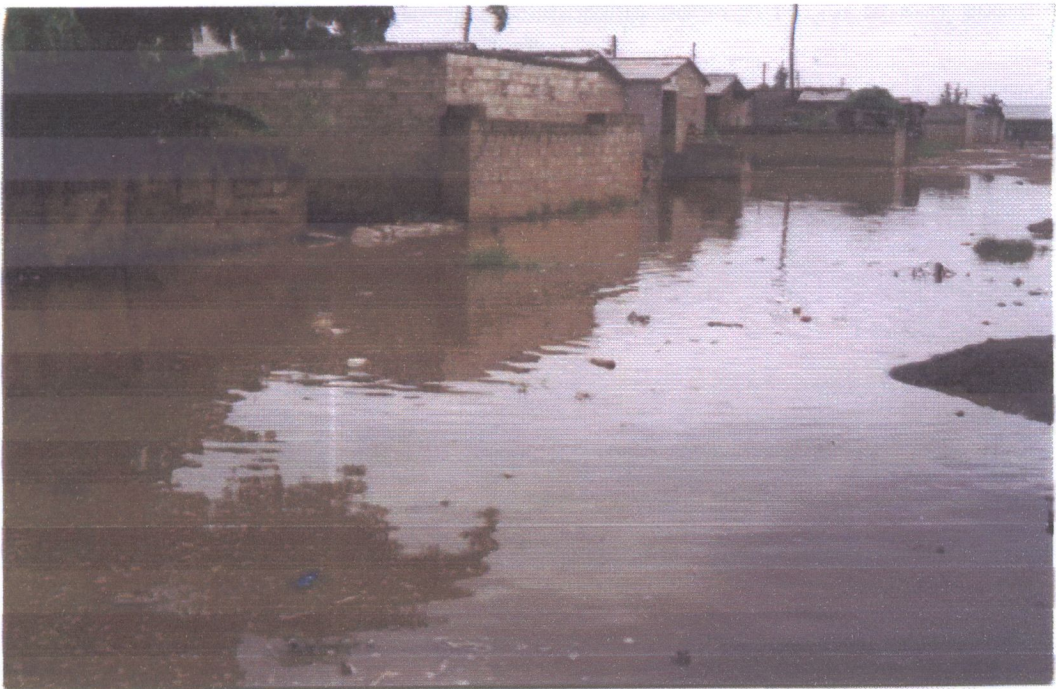
**Plate4; showing some flooded houses in Kanyama site and service**

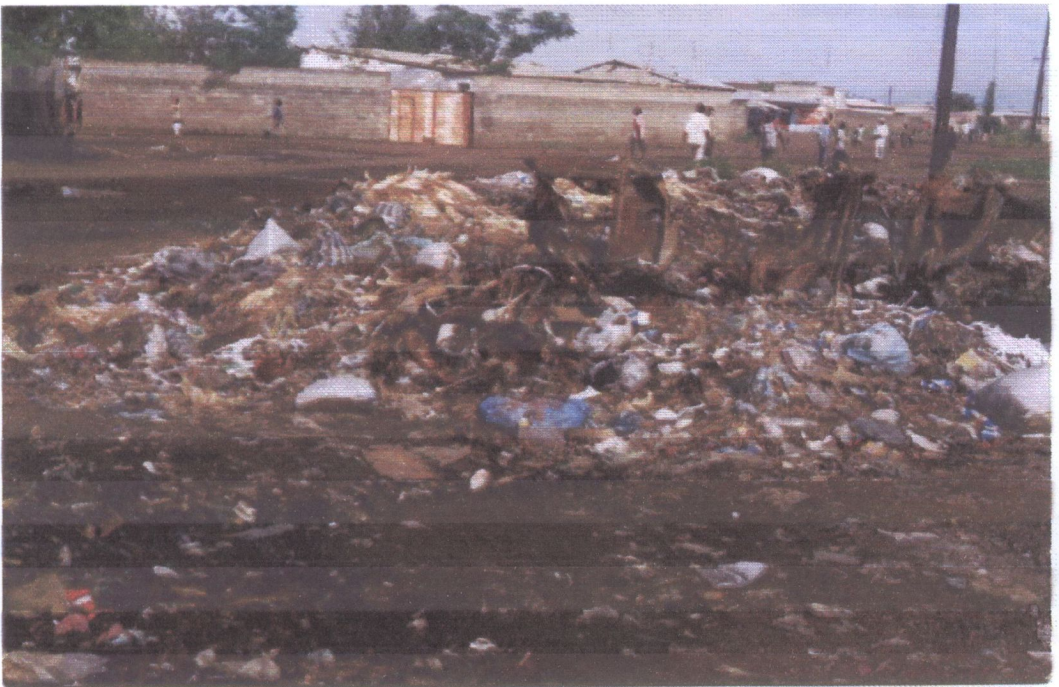
Plate5: Garbage dumped along the road

Figure8 shows the two possible alternatives were garbage is damped in Kanyama site and service. Most ditches were not dug for garbage disposal, they have resulted from sand mining and quarrying. In places were the ditches are filled up, the residents resort to dumping garbage on or along the roads (plate5)
