**EFFECTS OF HUMAN ACTIVITIES ON THE HYDROLOGY AND  
ECOLOGY OF CHASSA DAMBO IN SINDA AREA, EASTERN PROVINCE,  
ZAMBIA**

**A dissertation submitted to the University of Zambia in partial fulfilment of the  
requirements of the degree of Master of Science in Geography**

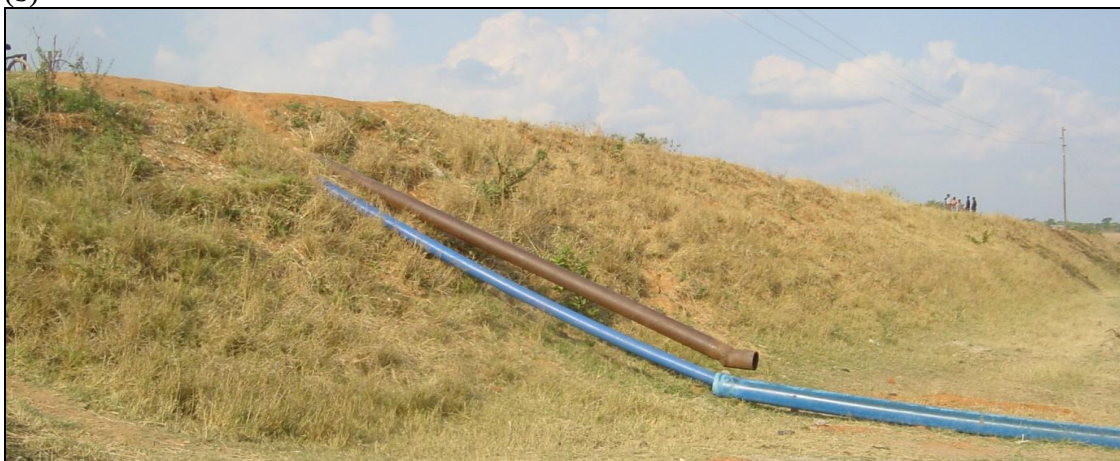
Figure 6: Photographs showing (a) excavated ditches in the upland areas of Chassa dambo and (b) the northern dam wall in Chassa dambo, October 2009. Source: Field data.

typical geomorphology of the dambo has been altered mainly by the two dam walls that were built across the dambo (Figures 6a). The dam walls altered the general elevation in the lower dambo. In addition, the geomorphology has been altered by the excavation of the upland areas of the dambo (Figure 6b).

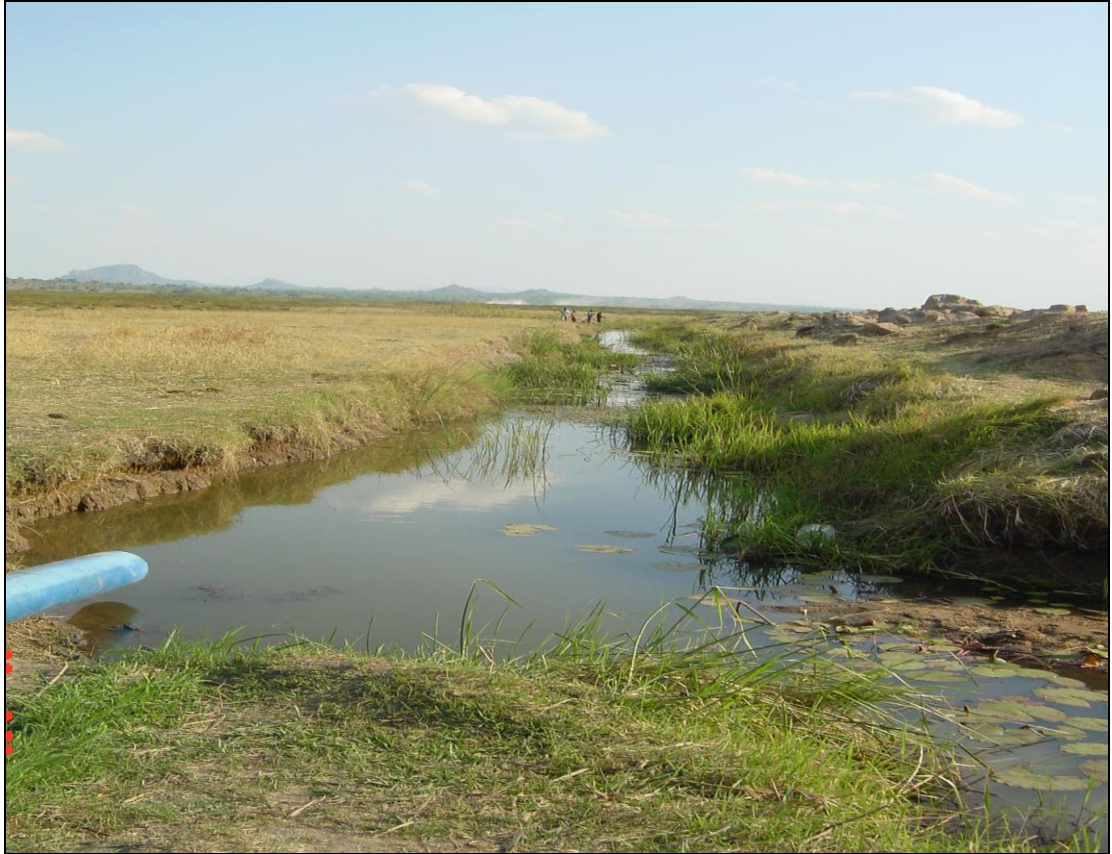
Figure 7: Photograph showing a pipe used for pumping water from the lower dambo into the Northern dam, October 2009. Source: Field data.

The morphology of Chassa dambo was altered mainly due to canalisation and draining of the middle dambo. A canal was dug to drains water from Nthongole, Kapoche, Kansansa and Kafunde streams to the Southern dam. Pipes were also used to drain water from the lower dambo to the Northern dam (Figure 7). Therefore, the

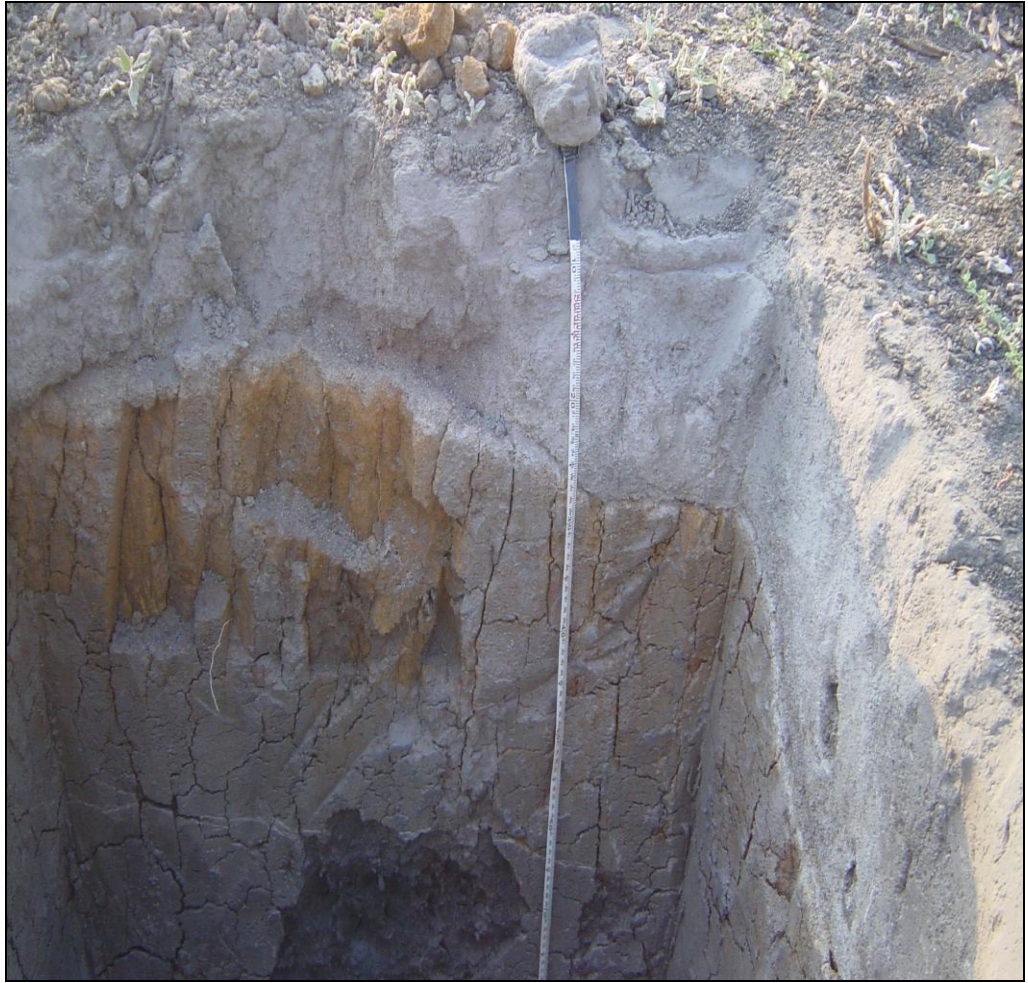
Figure 8: Photograph showing the soil profile at Pit 001, October 2009. Source: Field data.

The pit was dug at the base of the Southern dam. The top layer contained sandy clay loam instead of clay soil. The second contained sandy clay loam and the third layer contained sandy clay. The fourth layers contained coarse clay (Figure 8).

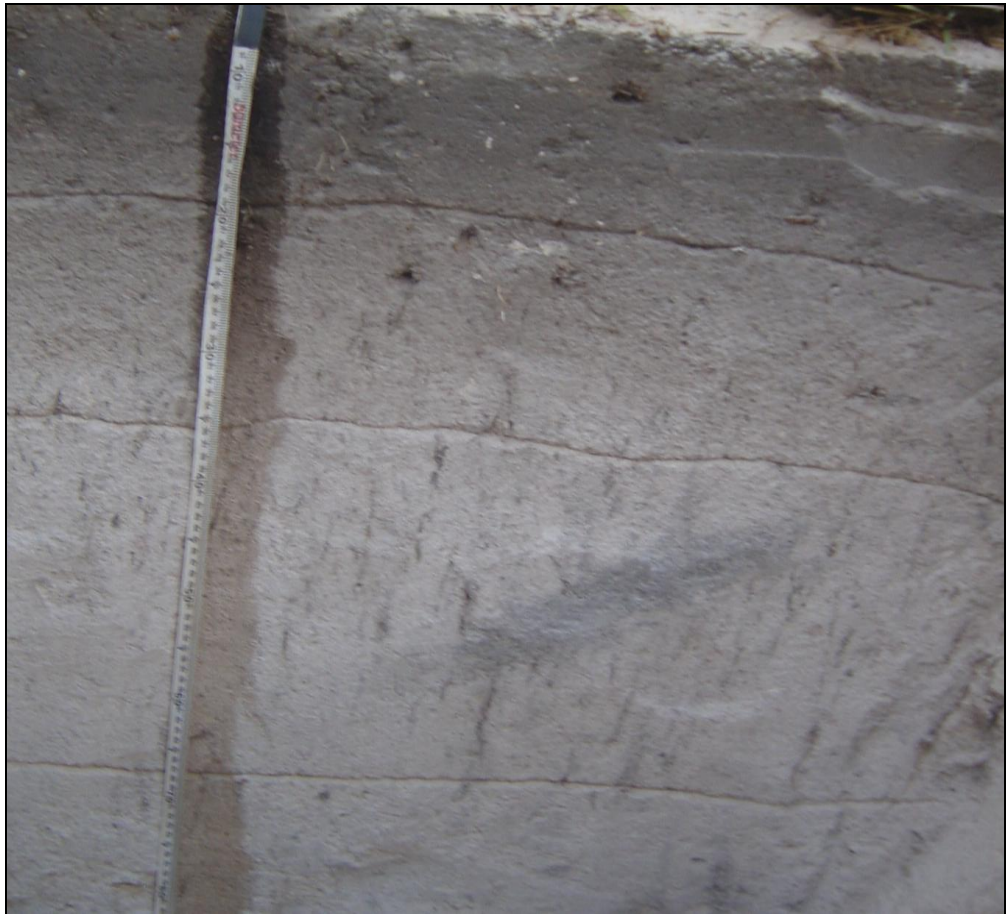
Figure 9: Photograph showing the soil profile at Pit 002, October 2009. Source: Field data.

Pit 002 was dug on the eastern side of the southern dam that is the dambo margin. The colour of the soil was bleached or white sand. The top layer contained silty loam whereas the second, third, and fourth layers contained sandy loam, sandy loam and sand respectively (Figure 9). The soils were moderately well drained and no appreciable water erosion was observed. The soils were generally weak, loose and non sticky.

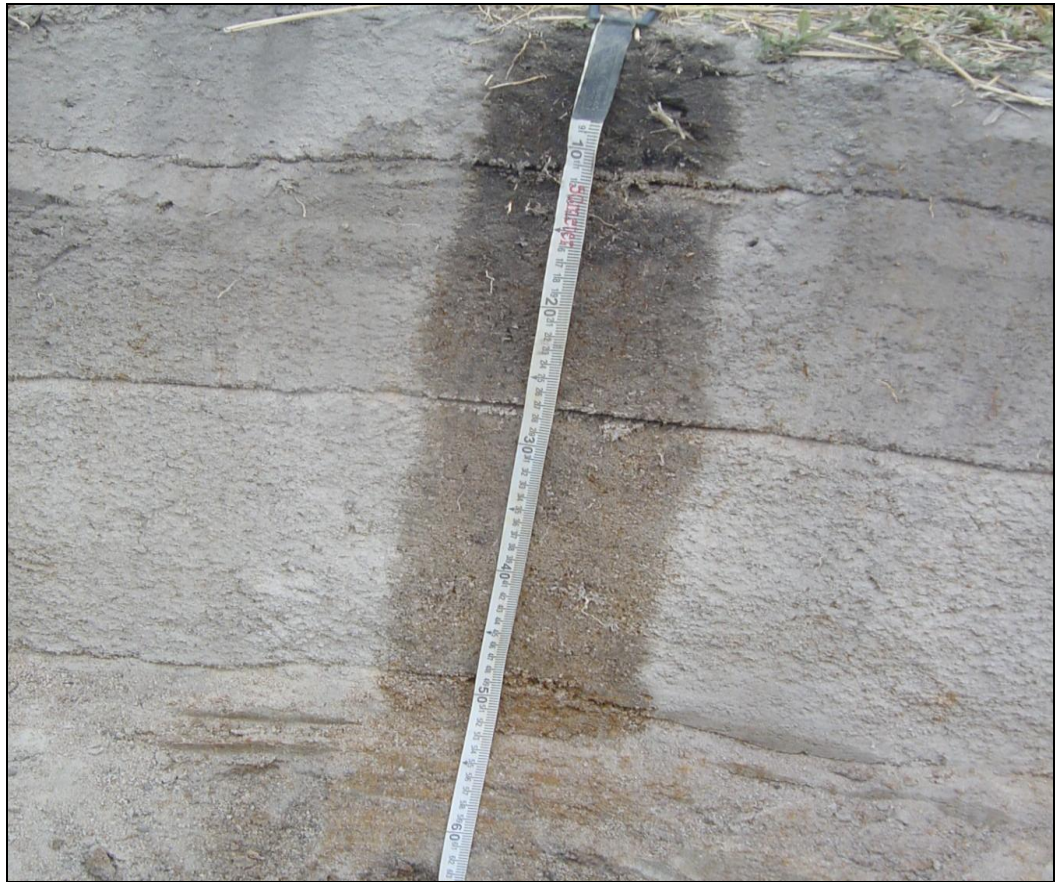
Figure 10: Photograph showing soil profile at Pit 004, October 2009. Source: Field data.

Pit 004 was dug at the dambo margin (Figure 10). The soils at Pit 004 were well drained. The first, second and third layers of the pit contained sandy clay

loam, sandy clay loam and sandy clay respectively. The soils from the upper layers broke into weak and fine sub angular blocky.

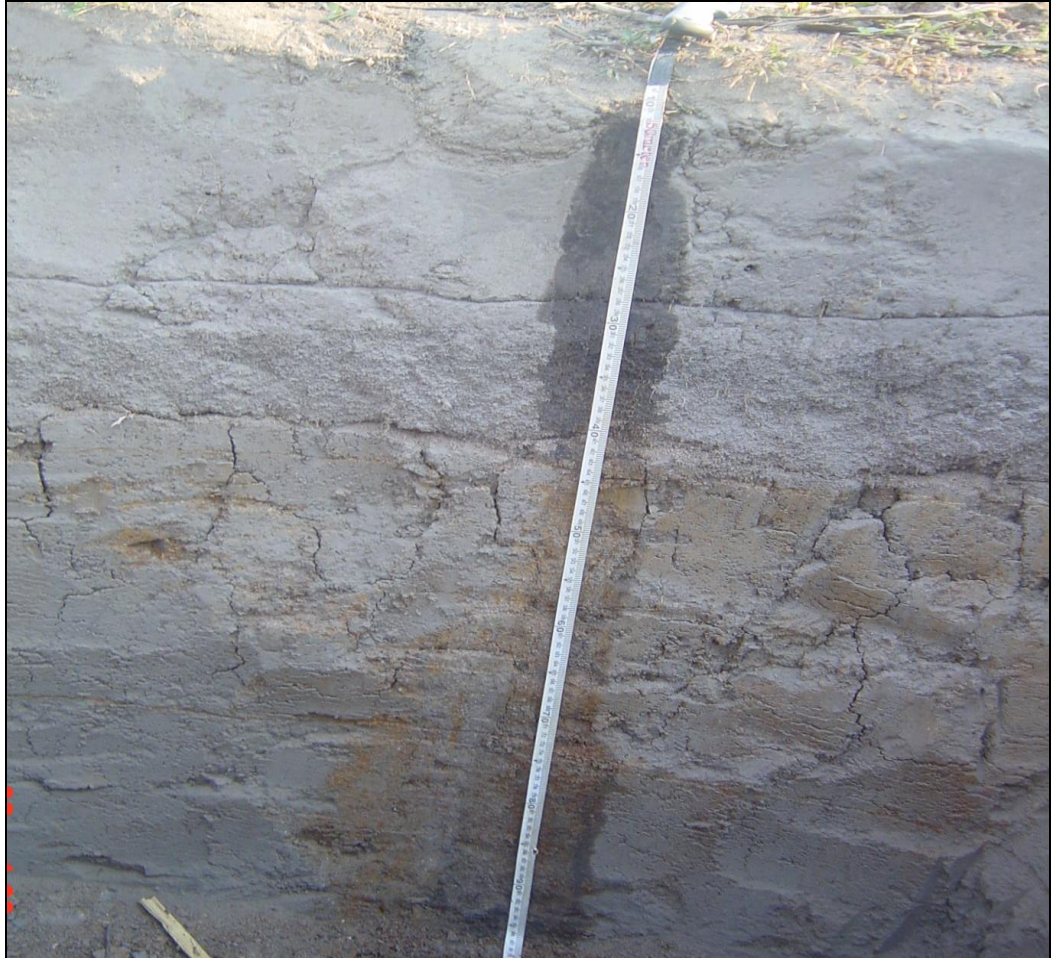
Figure 12: Photograph showing the soil profile at Pit 007, October 2009. Source: Field data.

- g. Pit 007; (031°41.255'E) and (14°13.624'S)** - The soils in Pit 007 were poorly drained. The pit was dug at the base of the northern dam. The first, second, third and fourth layers of the soil contained silty clay, sand, clay and clay respectively (Figure 12). It was observed that the second layer contained

deposited sand. The soils in the second layer broke into weak and coarse crumbs.

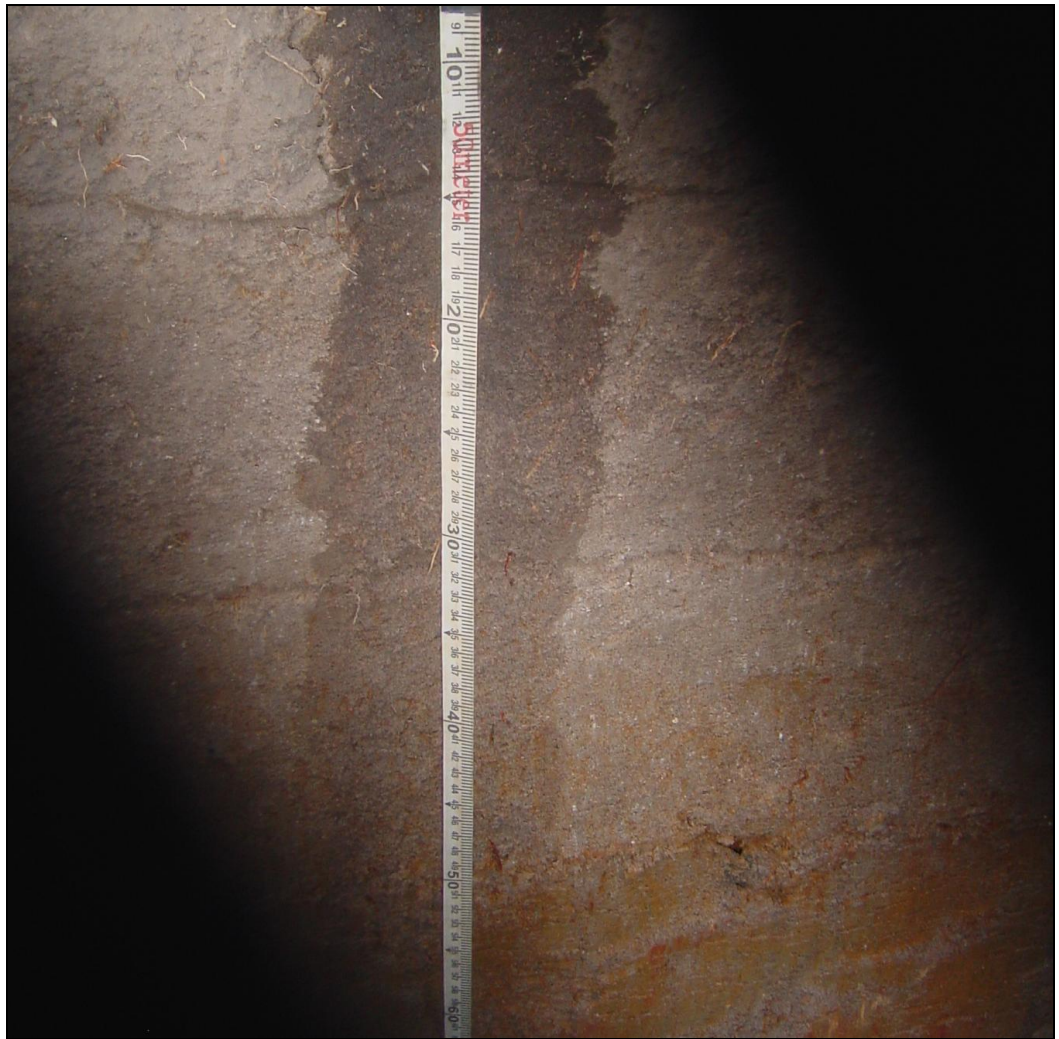
Figure 13: Photograph showing soil profile at Pit 008, October 2009. Source: Field data.

- h. Pit 008 (031°42.842'E) and (14°13.882'S)** – Pit 008 was dug at the headward dambo in Nthongole area where there was also burning, grazing and clearing of land for cultivation. The soils were poorly drained and floods were common (Figure 13). The first, second, third and fourth layers contained silty clay, sandy loam, sandy clay.

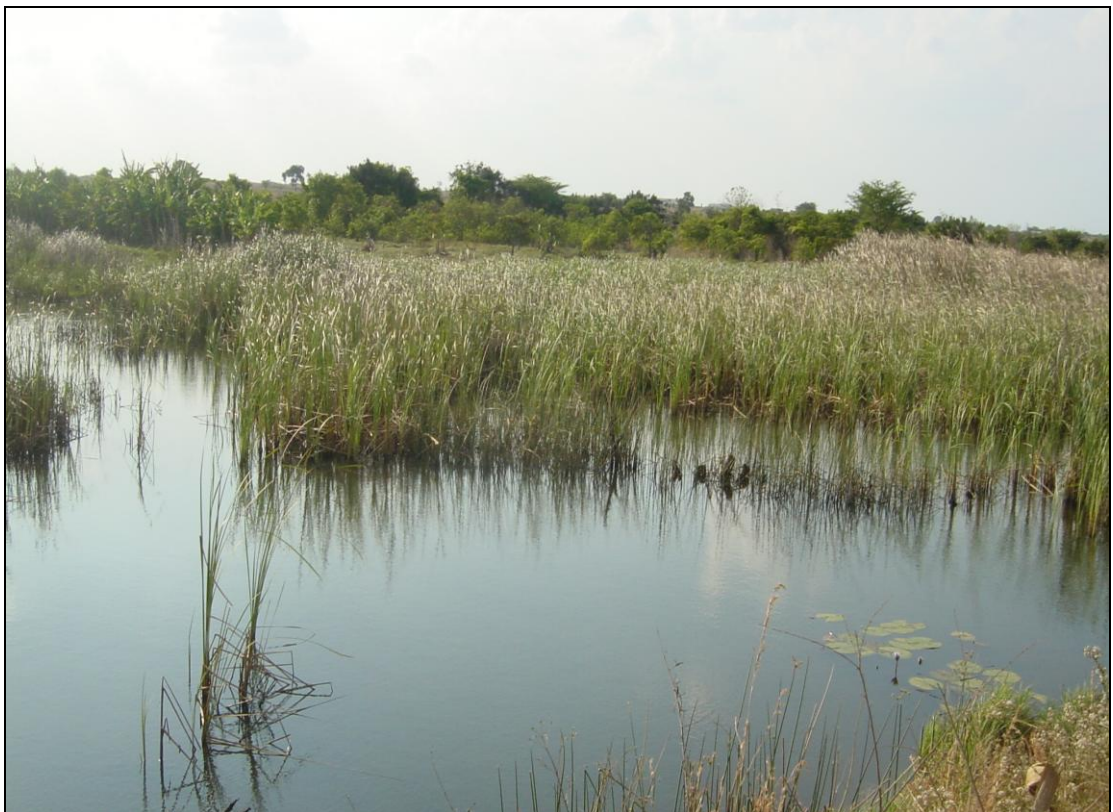
Figure 14: Photograph showing a portion of the waterlogged dambo, October 2009. Source: Field data.

During the early 1990s when commercial farming started in the dambo area, dams were created in order to store water for irrigation. Chassa stream was blocked by a high wall hence stopping the free flow of water through the dambo. This resulted in some areas of the dambo becoming drier. Such drier parts of the dambo were used to grow crops such as maize. At the time of the research, lime was being applied in the middle dambo in readiness for planting. On the western side of the dambo, a long canal was dug in order to divert water from Nthongole area, Kapoche and Kafunde streams to the southern dam. Nevertheless, the northern part of the dambo was water logged during the driest month of the year (Figure 14).

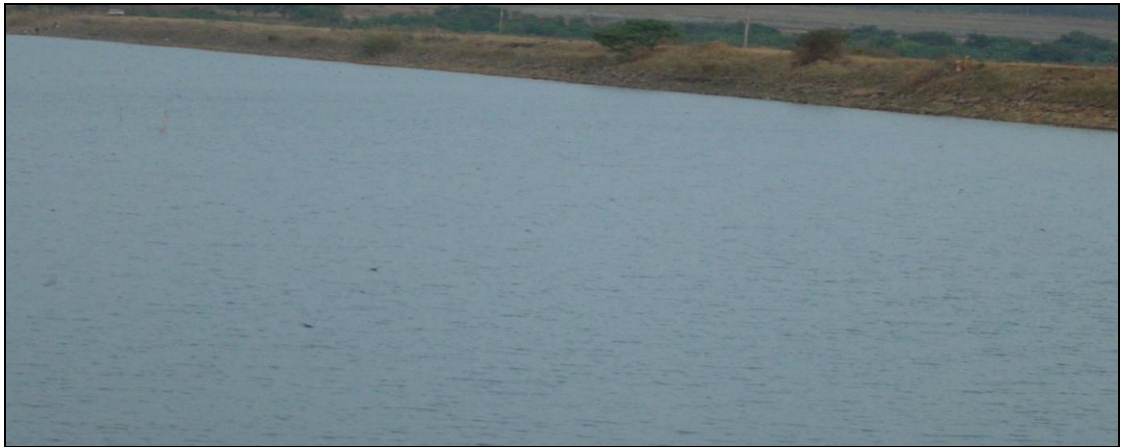
Figure 15: Photographs showing water in the Northern dam at the end of the dry season, October 2009. Source: Field data.

It was observed that the pumping of water from the lower dambo was being done to control water levels so that the cultivated middle dambo was not flooded. The source of water in the northern dam was the underground aquifer as the dam had abundant water (Figure15)

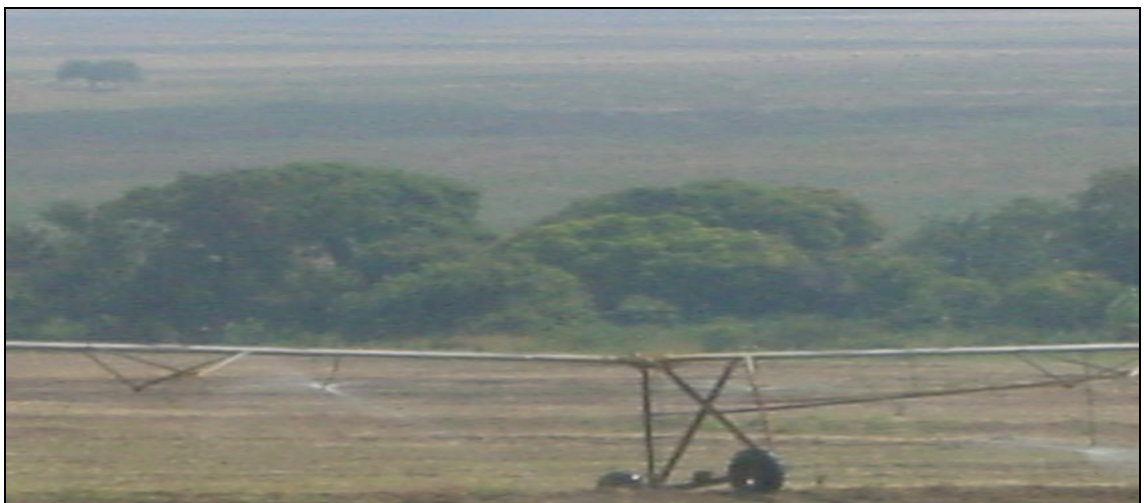
Figure 16: Photograph showing an irrigated wheat field in the upland area of Chassa dambo, October 2009. Source: Field data.

Much of the water stored in the dam is used to irrigate the wheat and maize fields in the upland areas (Figure 16).

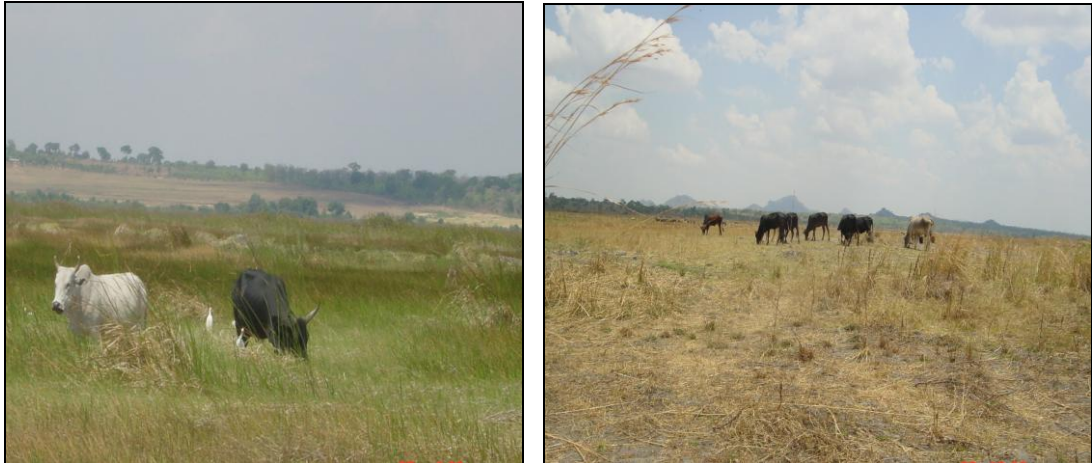
animals especially cattle and goats as these wetlands are rich in grass. Figures 21(a) and (b) show that the dambo is an ideal grazing ground for cattle. Grazing in the main dambo was allowed only when it was not under cultivation.

Figure 21: Photographs (a) and (b) showing cattle grazing in Chassa dambo, October 2009. Source: Field data.

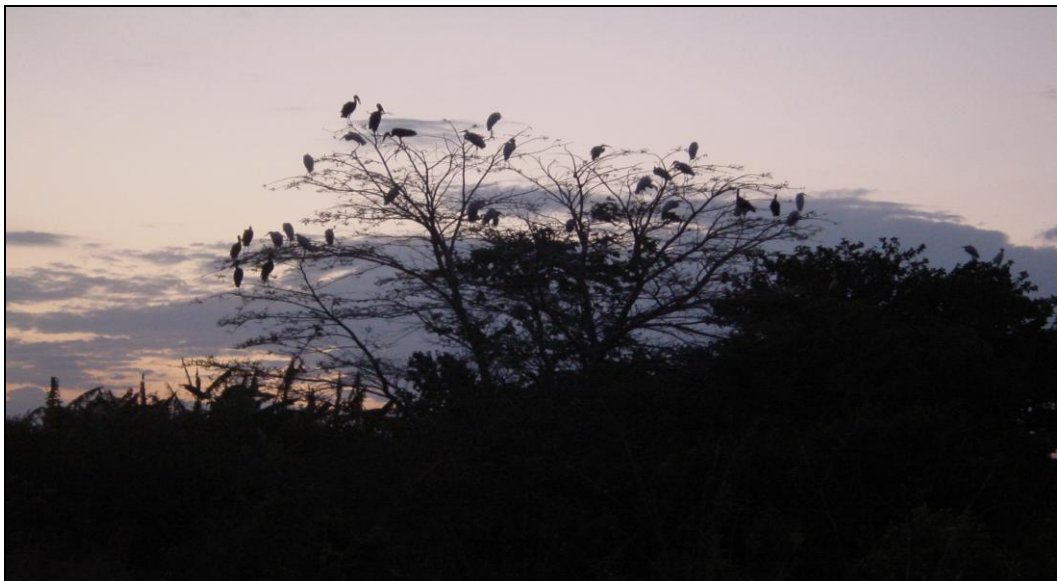
Figure 22 shows that trees in the dambo are an ideal habitat for birds. The *acacia albida* locally known as *Mtubetube*, is a tree that is ideal for bird nests.

Figure 22: Photograph showing bird life in Chassa dambo, October 2009. Source: Field data.

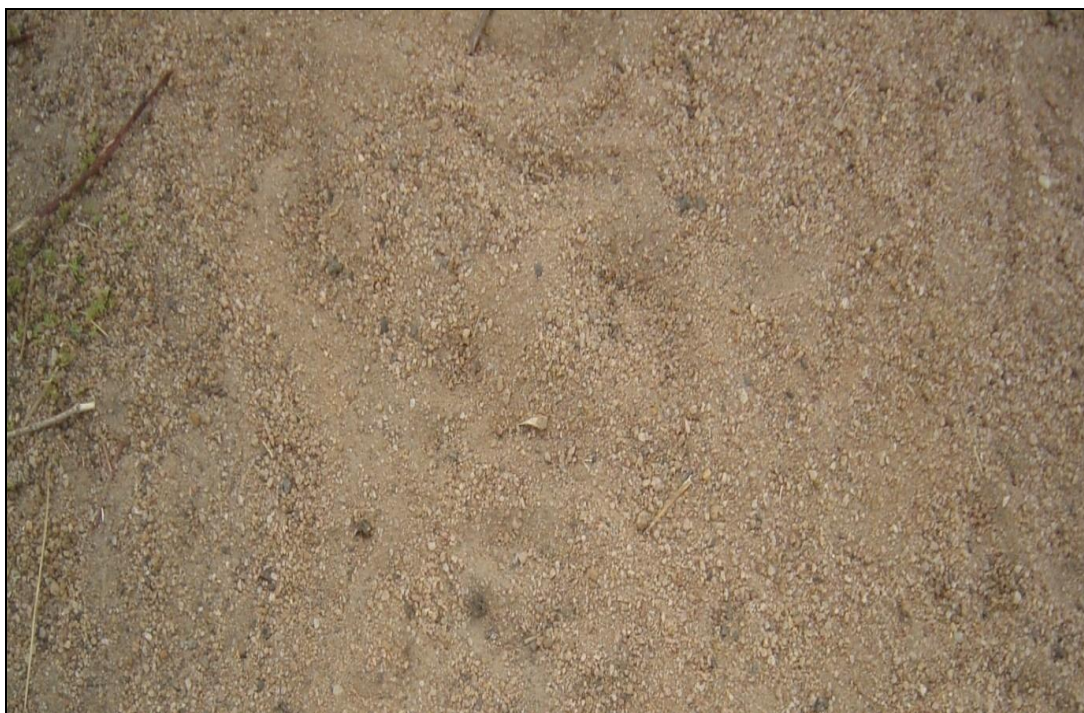
Figure 23: Photograph showing sand deposited at the base of the southern dam, October 2009. Source: Field data.

The ecology of Chassa dambo was also being affected by the change in the composition of the soil in the middle and lower dambo. Sedimentation or deposition of sand at the bases of the two dams was observed (Figure 23) and the second horizon at Pit 007 contained loose sand.

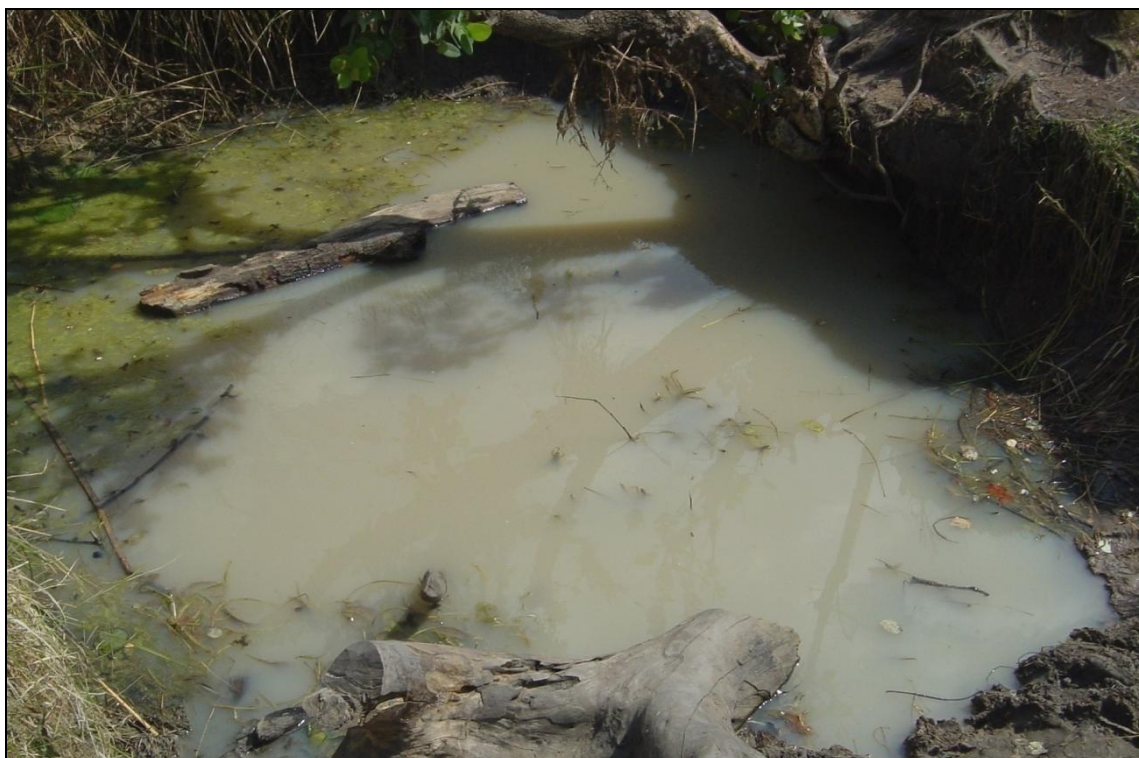
Figure 24: Photograph showing a shallow well in Nthongole area, October 2009. Source: Field data.

The information obtained from the respondents show that some respondents had multiple uses of the dambo. The uses of the dambo included cultivation of crops, growing of vegetables, fishing, source of water for drinking and irrigation, obtaining grass for thatching and grazing of domesticated animals. The findings show that 58.8% used it as a source of vegetables and fish and 36.3% of the respondents used it to catch fish for sale and consumption. The respondents who used the dambo for the cultivation of crops were at 25% and those who used it to grow vegetables for sale were at 28.8%. However, 75% of the respondents used the dambo as a source of water (Figure 24).
