**AN INVESTIGATION INTO THE FLOOD HAZARDS FACED BY
THE COMMUNITY LIVING NEAR KALIKILIKI DAM IN
MTENDERE COMPOUND – LUSAKA**

**CHRISPIN MOYO
(COMPUTER. No. 94223670)**

A Projected submitted to the Department of Geography at the University of Zambia in partial fulfillment of the degree of Bachelor of Science, BSc.

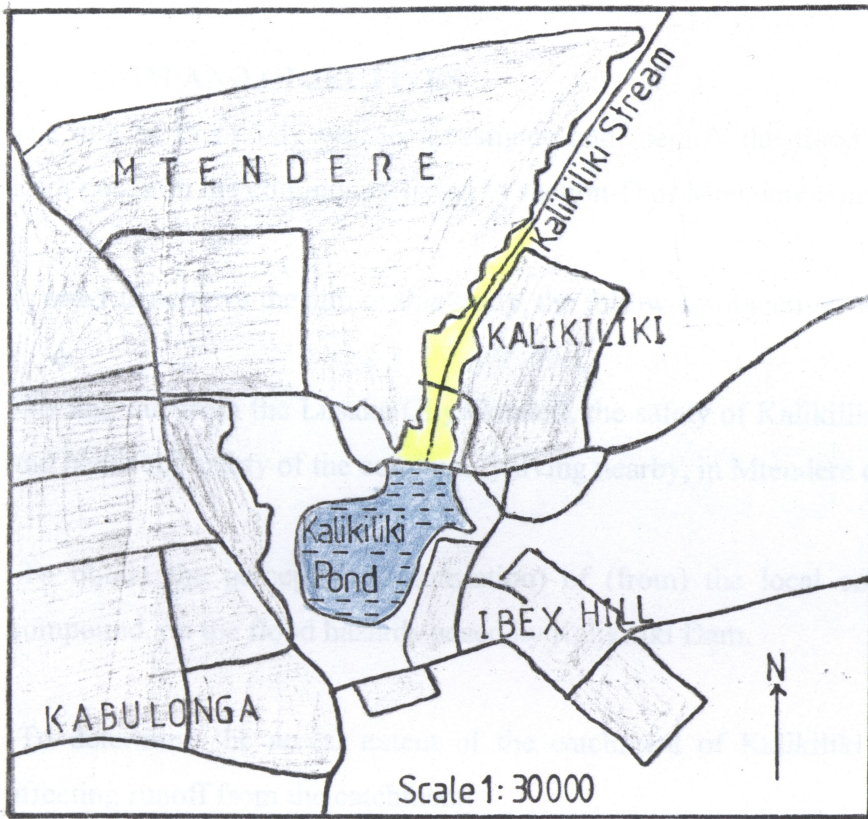
FIG.1.1 MAP SHOWING UNSETTLED LAND ALONG KALIKILIKI STREAM BEFORE 1992

In 1992, according to local residents, Kalikiliki Pond dried up completely following the drought that was experienced in the area (along with many other parts of the country) during the 1991-92 rainy season. This attracted people to settle down stream, adjacent to Kalikiliki stream which dried up too. Prior to the 1992 drought, the area of land adjacent to Kalikiliki was unoccupied. Figure 1.1 shows the land in question.

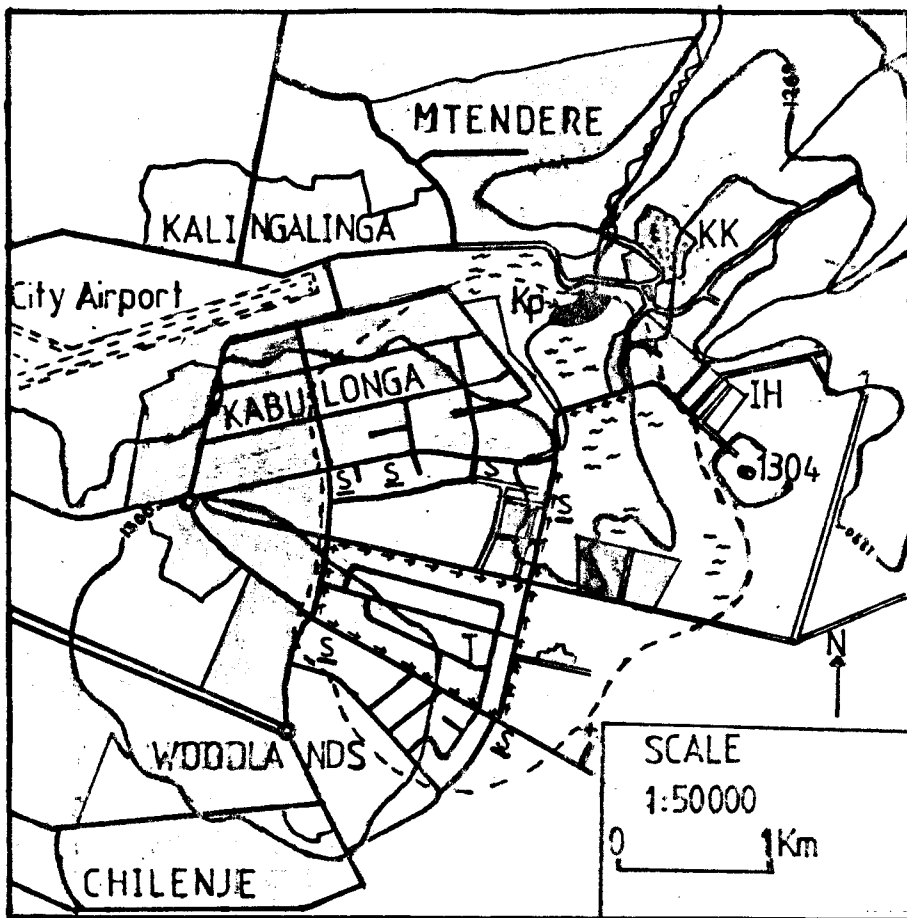
FIG.5.3 MAP SHOWING THE CATCHMENT AREA OF KALIKILIKI POND

Figure 5.3 shows the catchment of Kalikiliki Pond. The figure also shows the surface land cover factors that affect runoff from the catchment.

The catchment area of Kalikiliki Pond is largely built-up with urban type of development (figure 5.3). The built-up areas are mainly residential areas with tarred roads. According to MAFF(2000) in table 2.1, residential areas have a runoff coefficient range of 0.3-0.5. This implies that the residential areas in the catchment area of Kalikiliki Pond produce 30%-50% runoff from rainstorms experienced in the area. Tarred (asphalt) surfaces yield 85% - 100% runoff from individual rainstorms (Table 2.1). It can be seen from figure 5.3 that the catchment area of Kalikiliki Pond has main tarred roads. The main roads in the area have surface storm drainages which empty runoff into Kalikiliki stream. Hall (1994) argues that storm drainages accentuate the flow of runoff to the streams they have designed to empty into.

The topography of the catchment of Kalikiliki Pond is generally not flat. There is a difference of 34 meters between the highest and the lowest points in the area (from figures 5.2 and 5.3). This means that the topography of the catchment influences runoff. The shape of the catchment, which is fan-shaped or compact (Figure 5.3), also promotes quick runoff from the area.
